Oregon Department of Fish and Wildlife

Use of a Side Scan Sonar to Describe Habitat Condition in the Columbia Slough

Progress Report No. OPSW-ODFW-2019-5

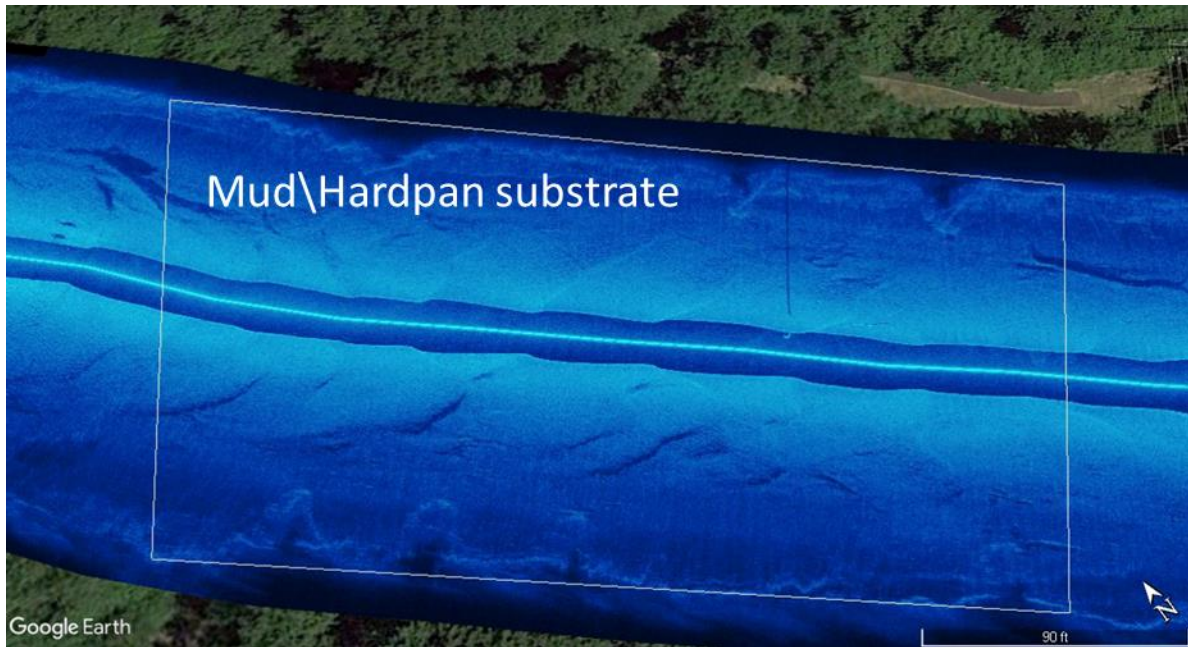
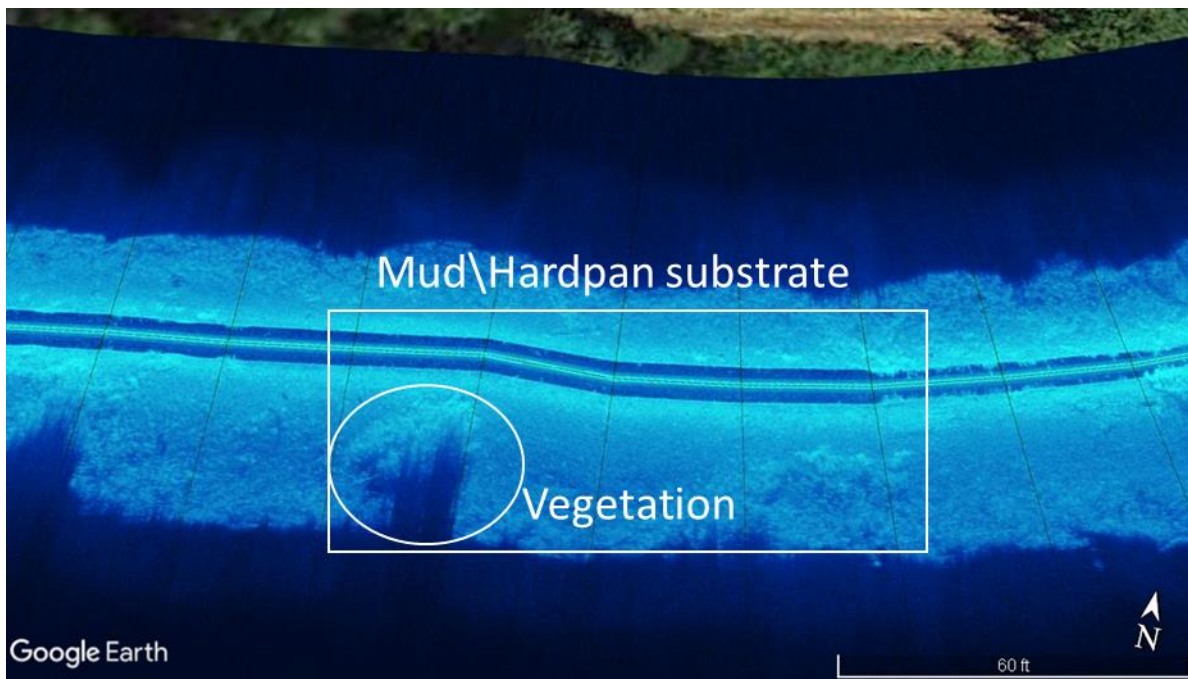
The substrate of the Columbia Slough consists primarily of mud\hardpan throughout the entire length. Concentrations of vegetation are dense and more prolific in the shallow upper reaches of the slough.

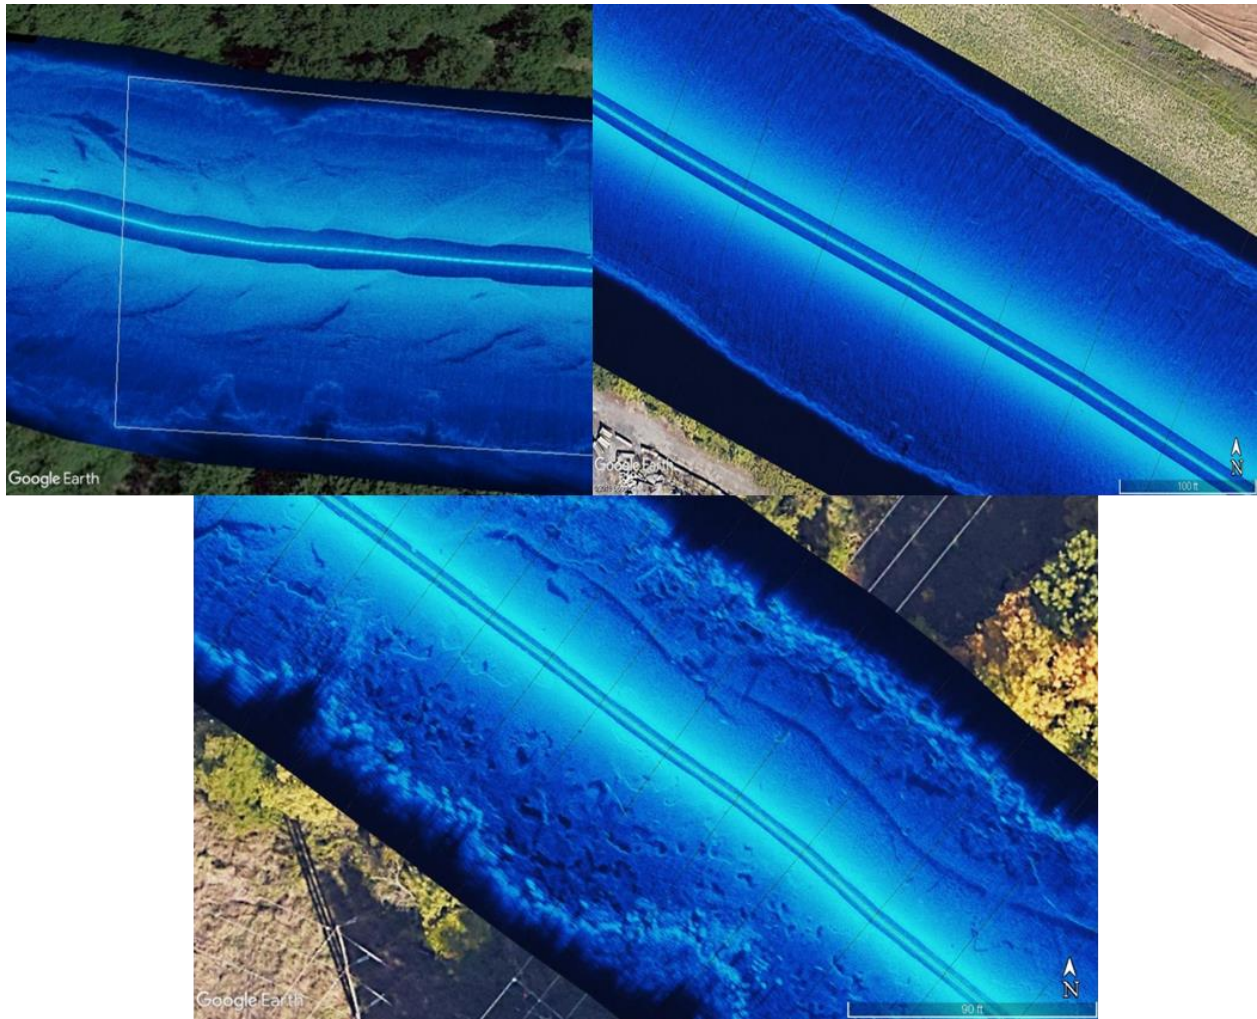
The substrate in Reach 1 consisted primarily of mud and hardpan. The top left photo shows the hardpan substrate on the lower Slough, near where it empties into the Columbia River. The ripple effect seen here is likely related to the tidal influence of the Columbia River. The top right image shows smooth mud substrate, the dominate substrate of the Slough. The bottom photo shows mud with what appears to be burrows.

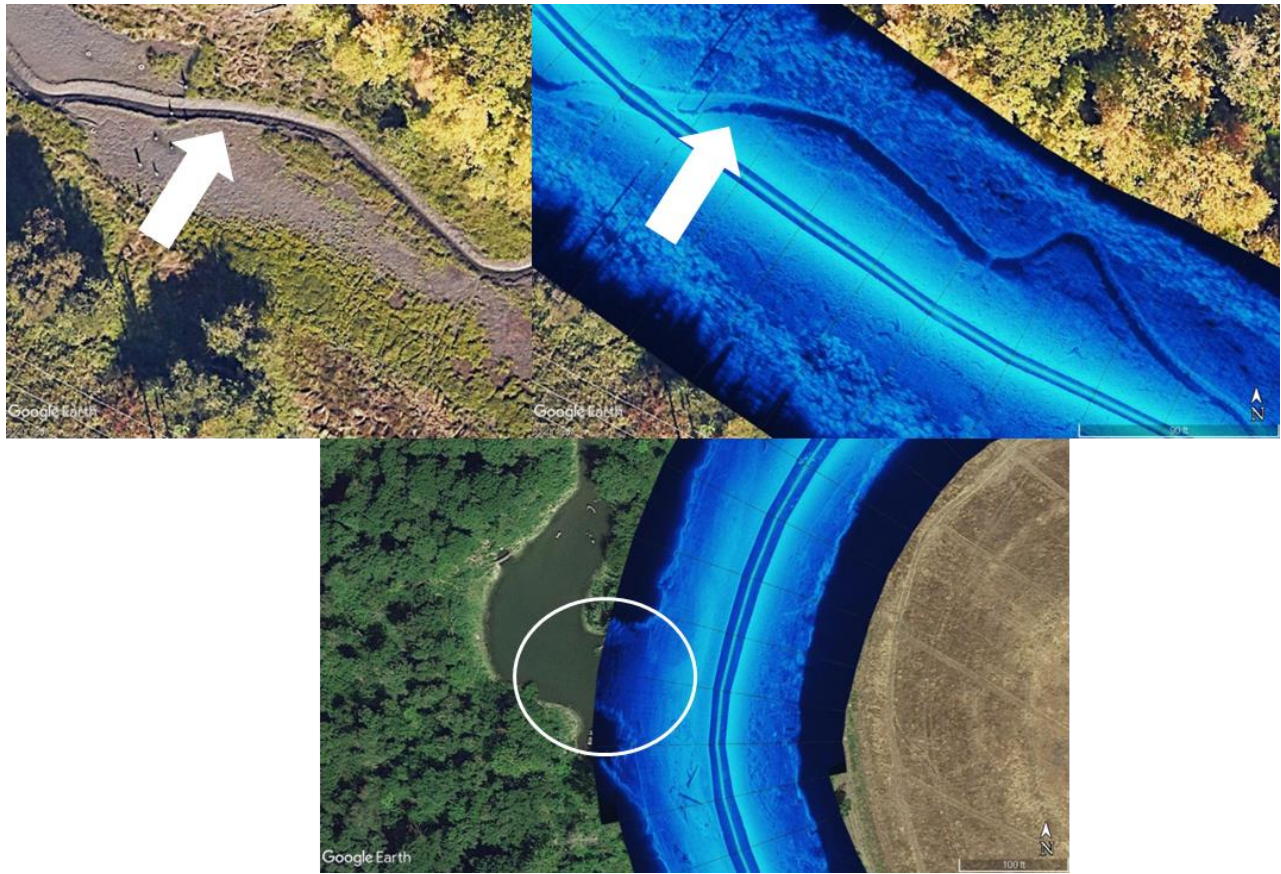
These photos from Reach 1 illustrate some interesting channel bed irregularities. The top left photo shows what appears to be a deep track in the sediment, while the top right image reveals that this is what remains of the water channel at low water. The sonar image was recorded in May 2019, while the image from Google Earth is from July 2018, and illustrates the absence of water later in the year.

The bottom image shows a water input or output nearby, in contrast to the appearance of banks.

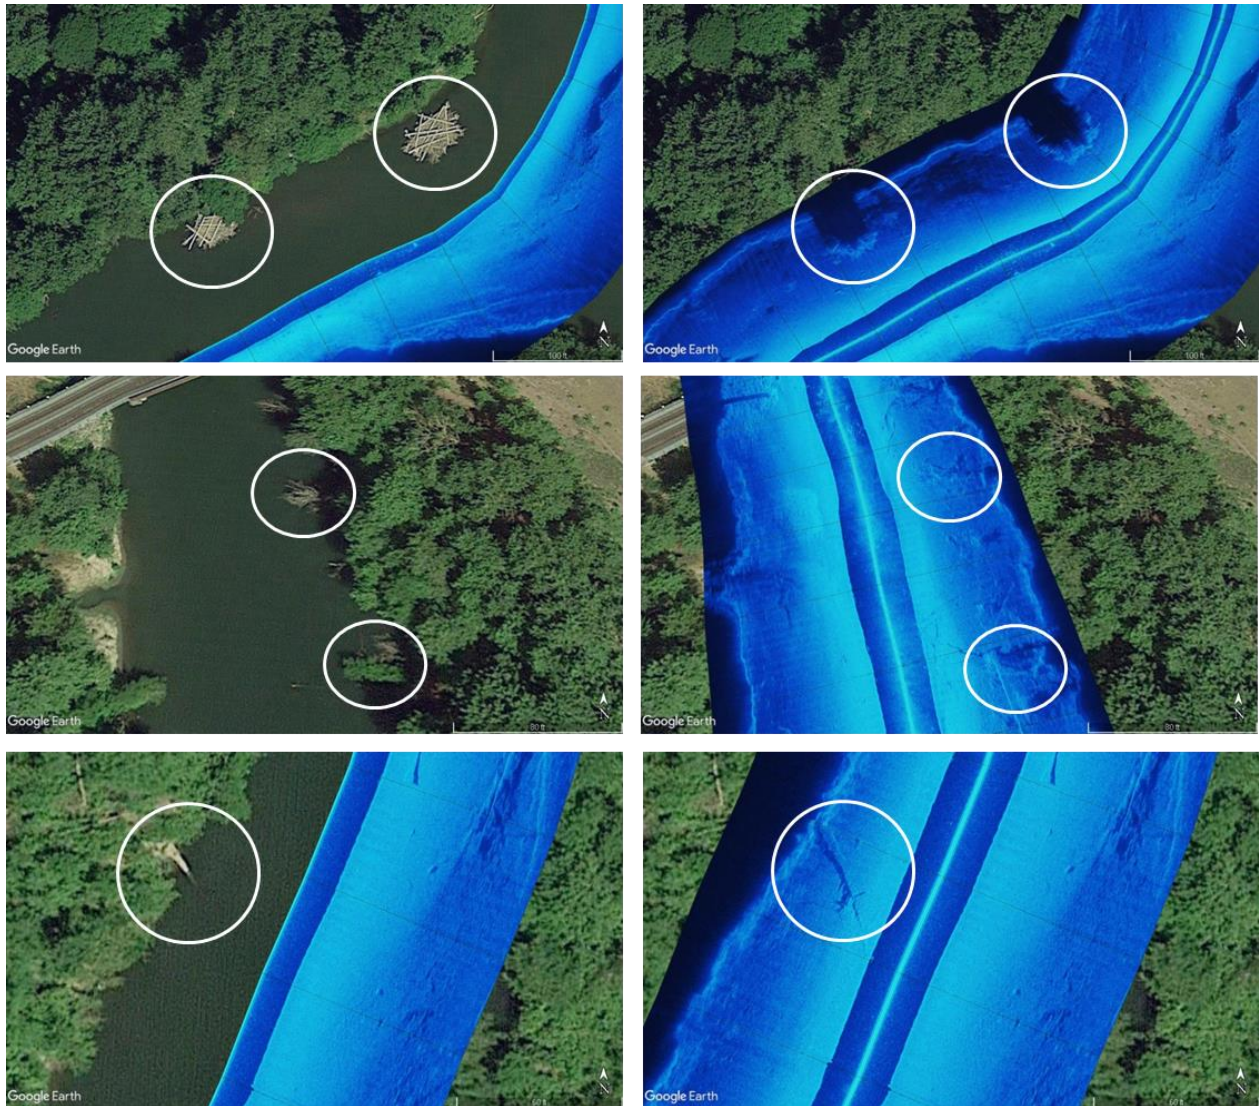
Reach 1 wood observations; wood structures that have been placed into the Slough as well as trees and branches that have fallen into the waterway. Various types of wood can be seen in the above images with and without the sonar overlay. The top two sets of images show wood structures that have been placed in the Slough, while the bottom set of images shows a fallen tree.

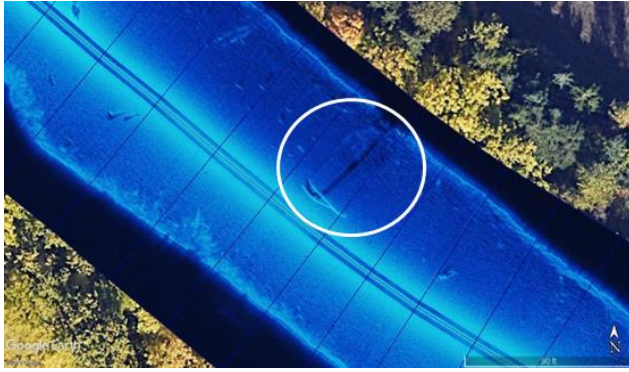
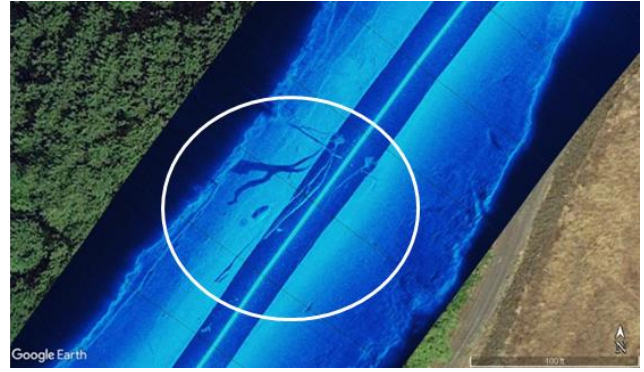
Tree branches, Reach 1: The shadow behind the image on the left shows that the branch extends up into the water column on the left hand side of the sonar transducer, while the image on the right shows the branches extending up into the water column directly under the transducer.

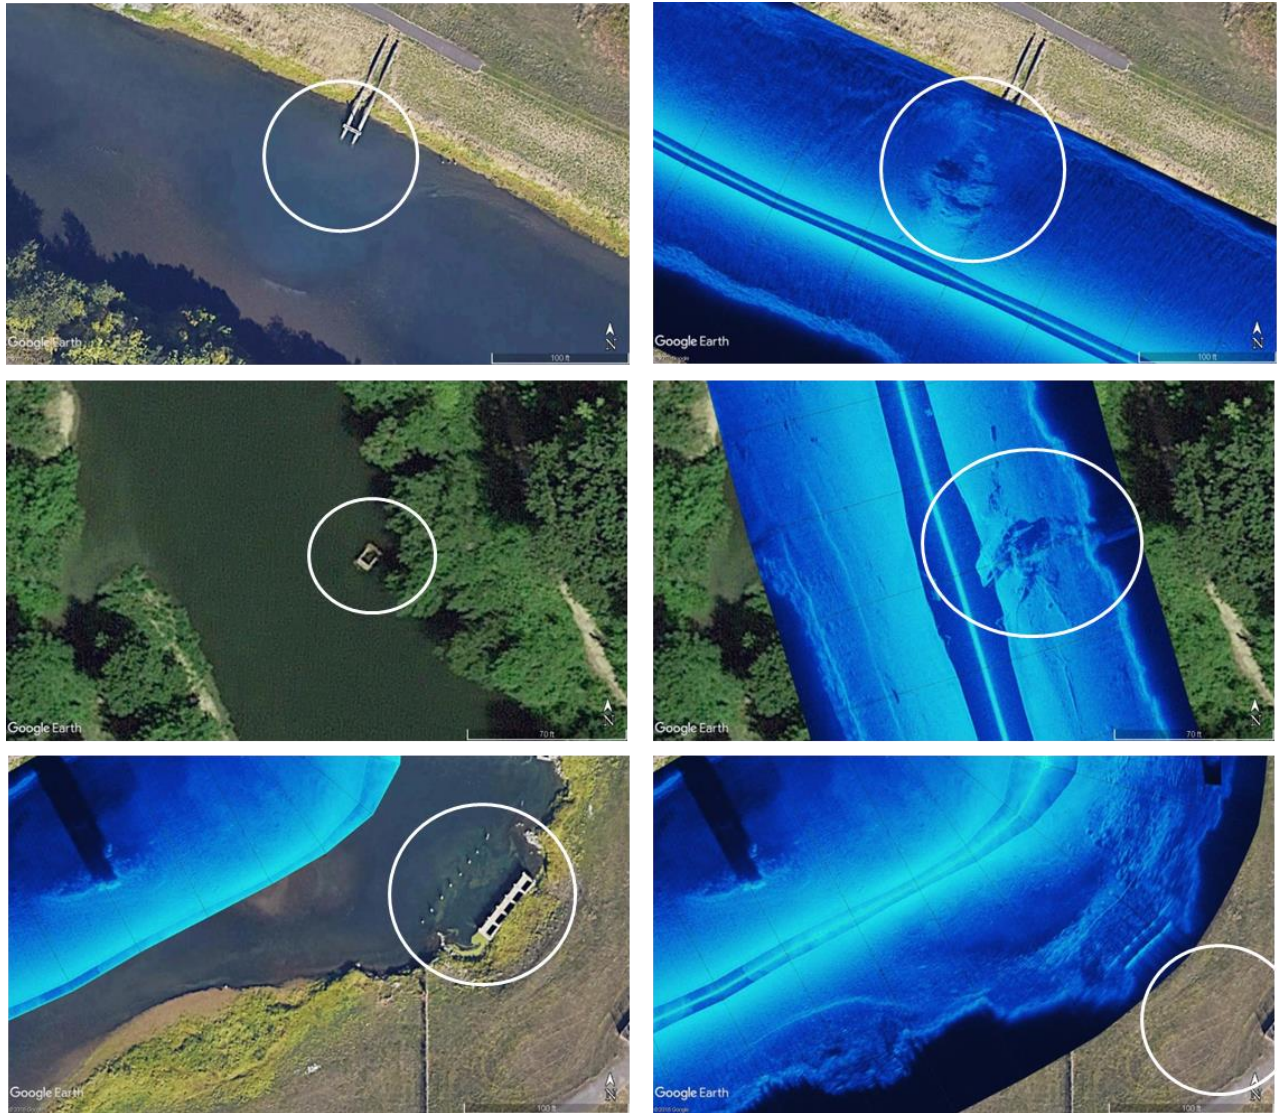
Reach 1 water flow; various types of structures affecting water flow can be seen in Reach 1 with and without sonar. The sonar overlay in the top set of images shows how flow from these pipes has affected the sediment. The sonar overlay in the middle set of images shows how this structure extends up into the water column. The bottom set of images shows an above and underwater view of the structure at the west side of the Elrod Levee.

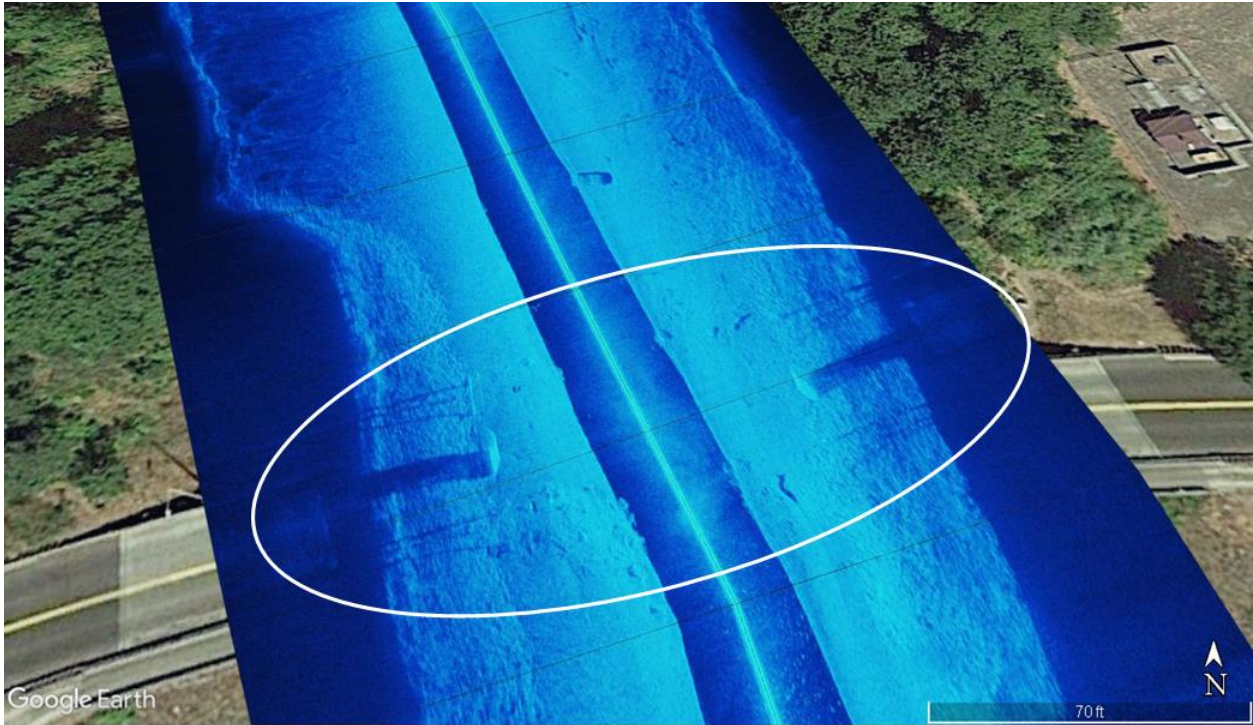
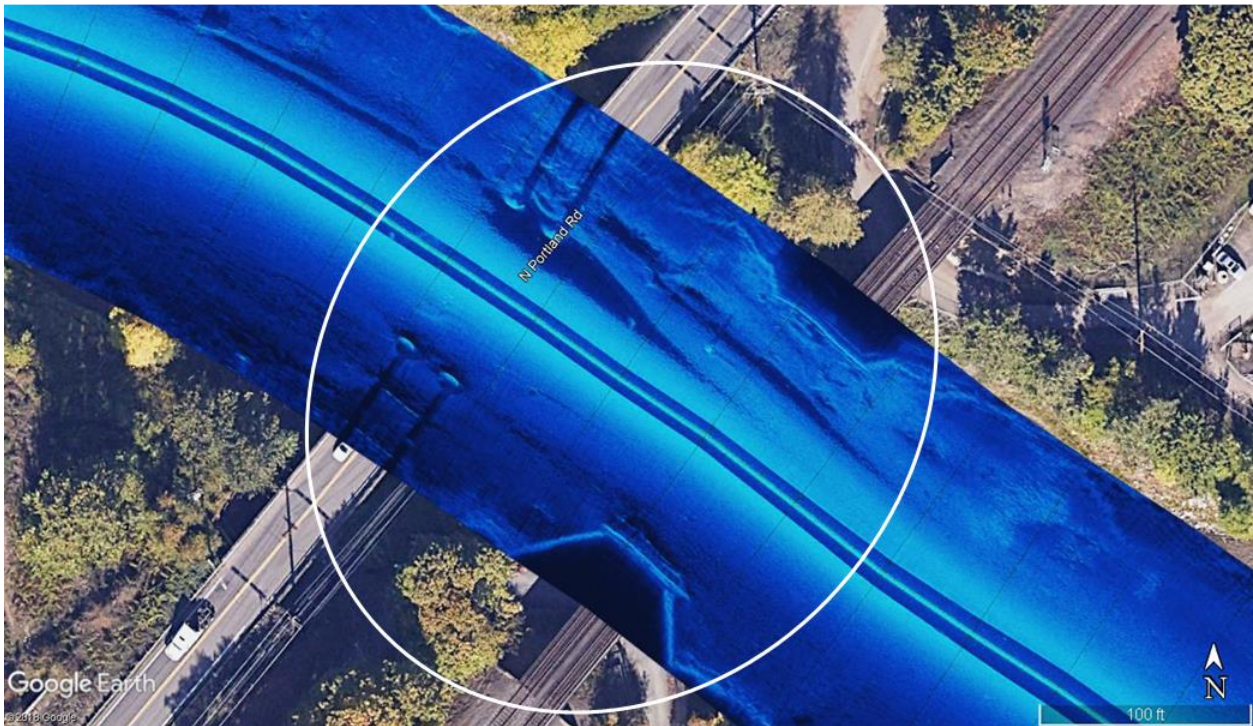
Reach 1 bridge structure; the various types of supporting foundations for bridges can be seen in Reach 1. These include North Lombard Street near North Kelley Point Park Road (top), and a bridge on North Portland Road and its neighboring railroad bridge (bottom).

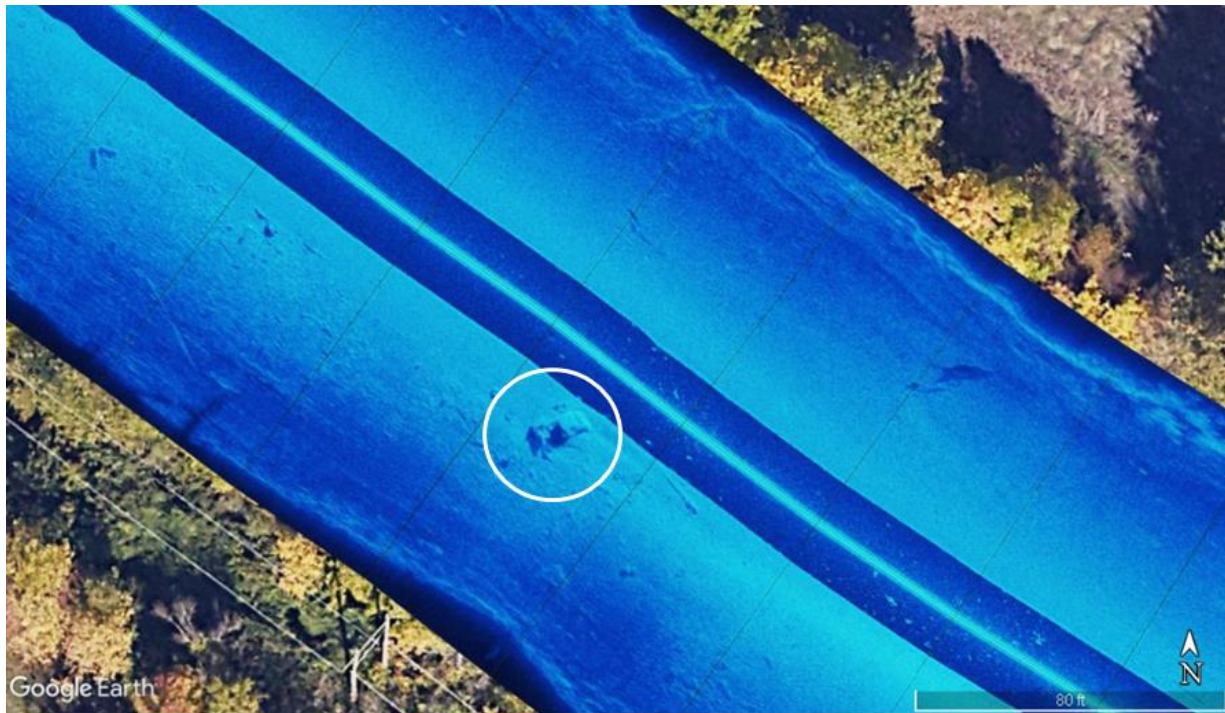
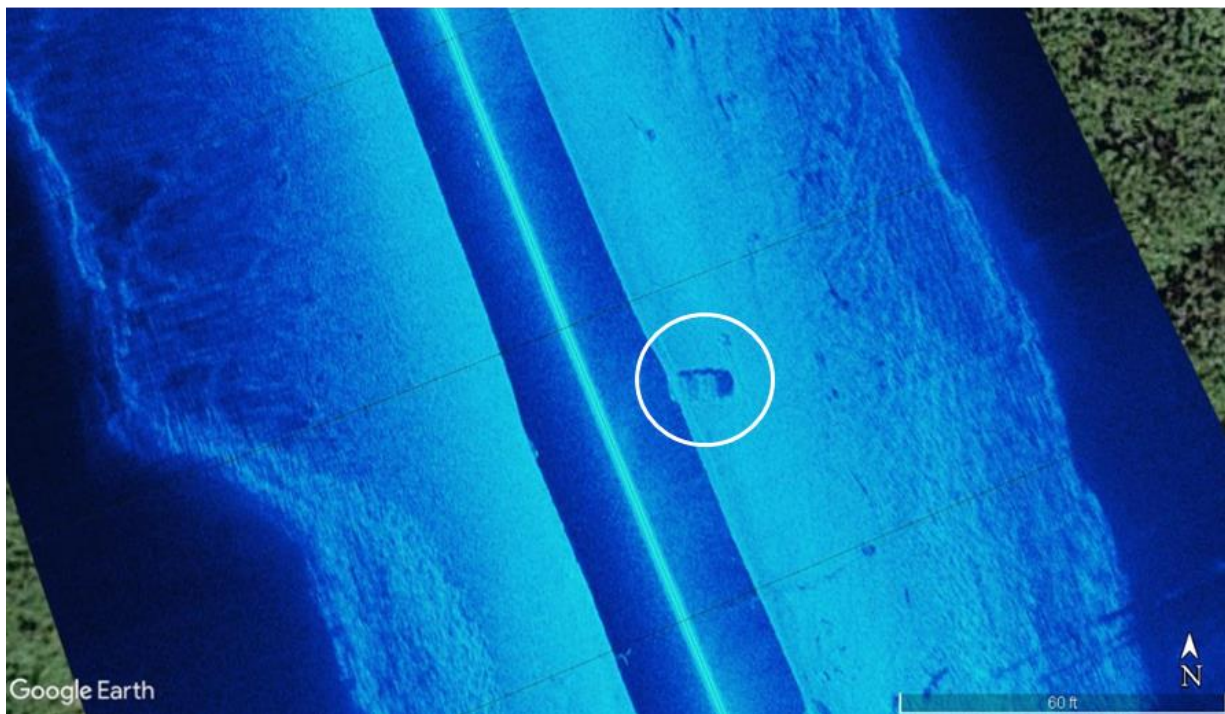
Reach 1 also contained some man-made objects that were unanticipated, such as these two objects that appear to be cars.

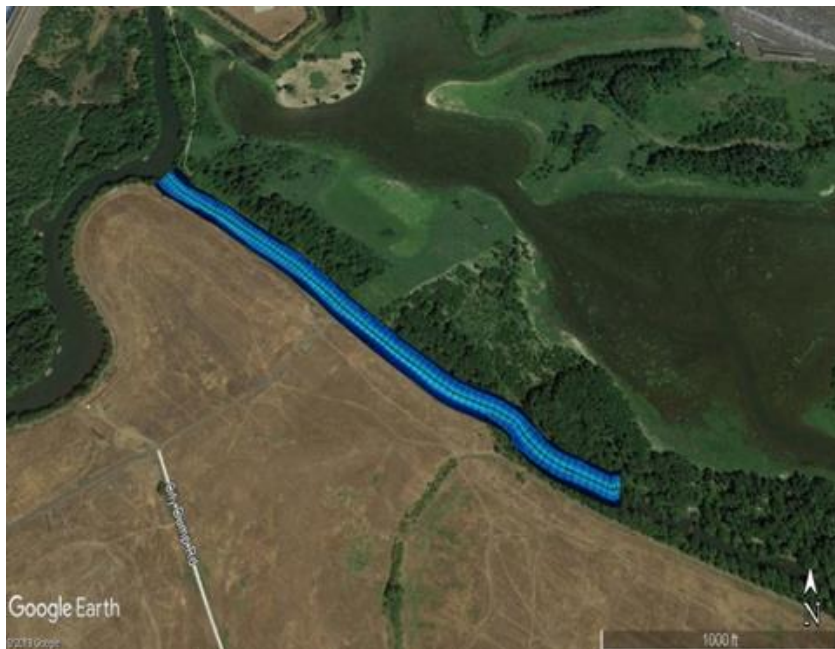
The substrate in Reach 2 consisted of mud \hardpan throughout the entirety of the side channel. Also of note are many pieces of large wood. Several schools of fish were observed with the sonar as well.

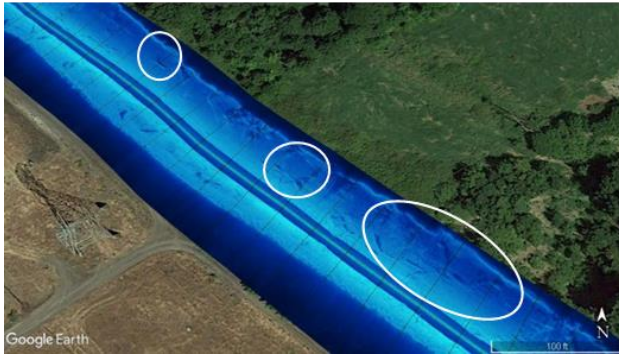
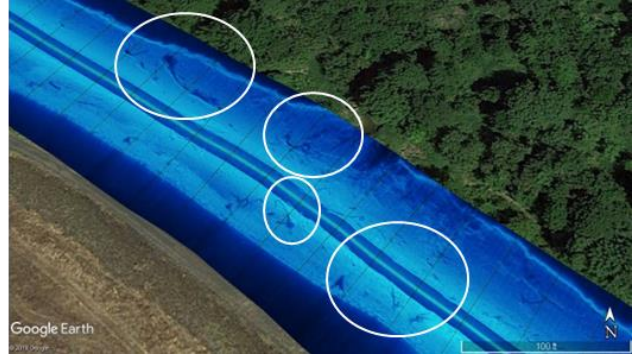
Highlighted above are a number of large wood pieces seen throughout the side channel.

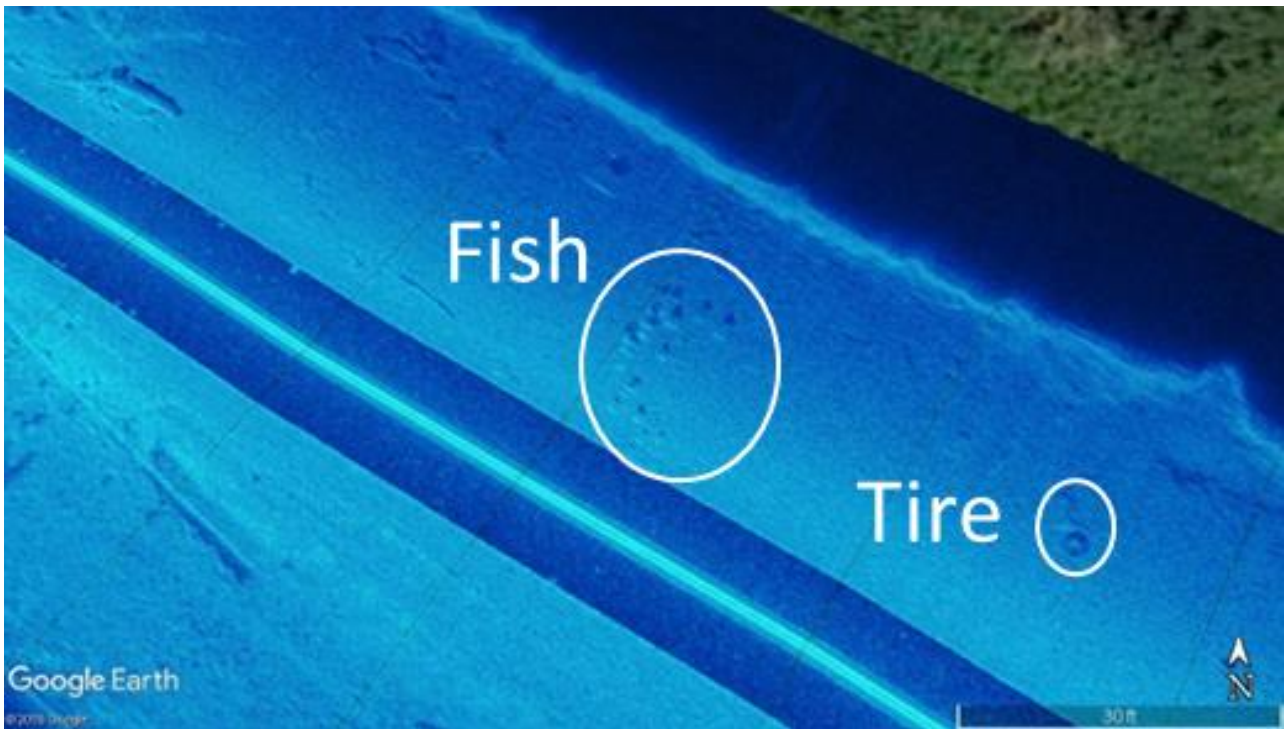
The image above shows a school of fish and a tire.

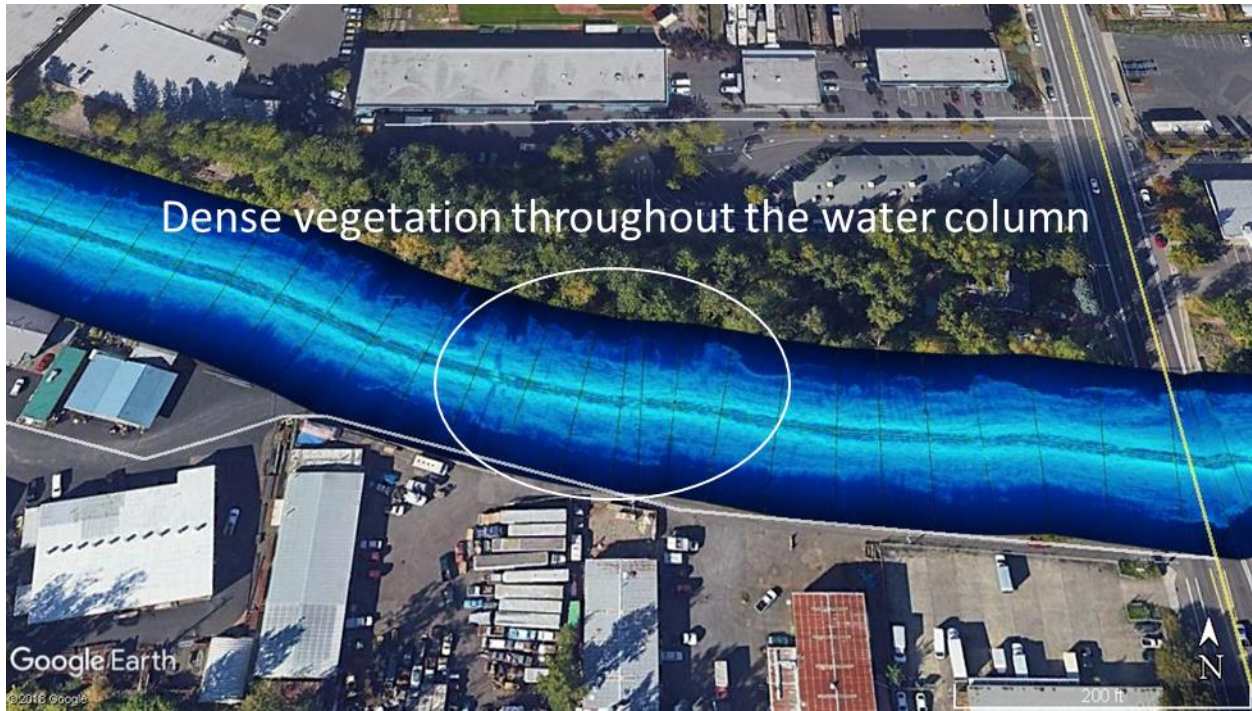
Dense vegetation throughout the water column

The substrate in Reach 3 was mud and the water column had dense vegetation. We found very few pieces of submerged wood in this reach.

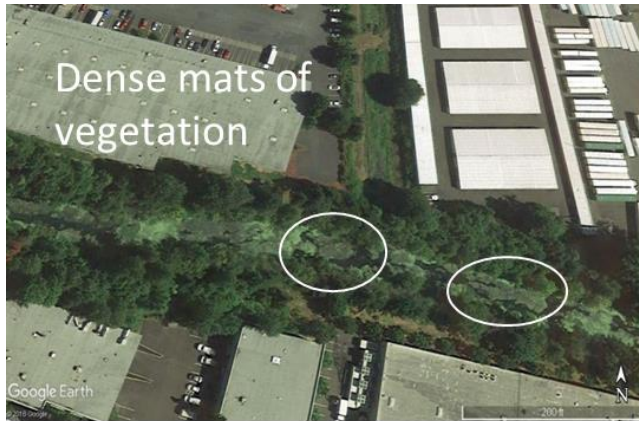
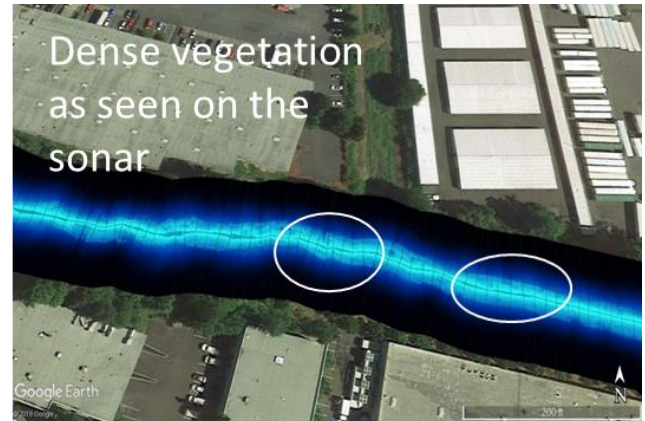
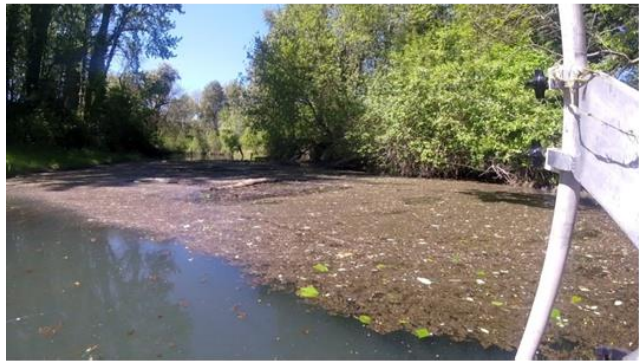
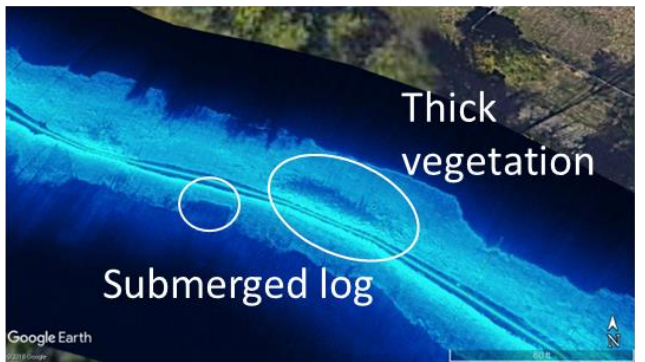
This section of the slough is narrow and shallow, and heavily inundated with vegetation. The substrate is mud/hardpan throughout. At several locations within this reach the vegetation is so thick that it is nearly impassable. The images above highlight some of the dense vegetation in Reach 4.

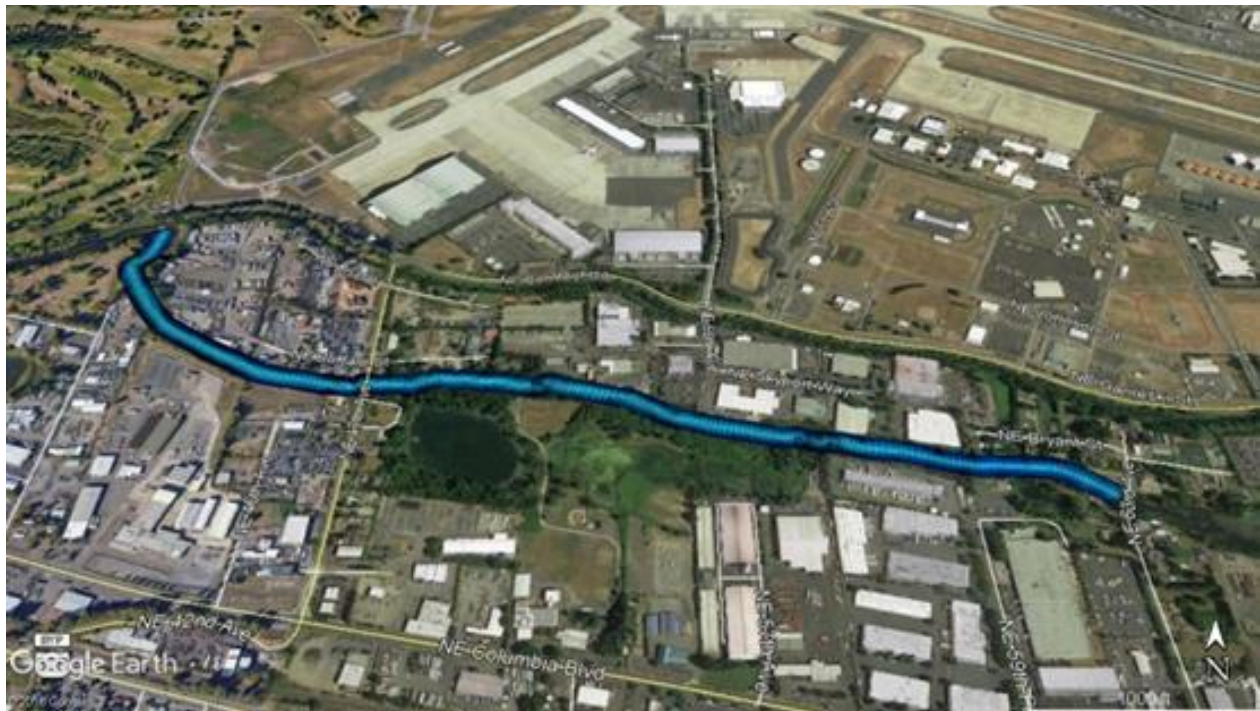
The above image shows the extent of sampling for Reach 5. We were only able to survey up to 63rd street due to a culvert that made further boat travel impassible.

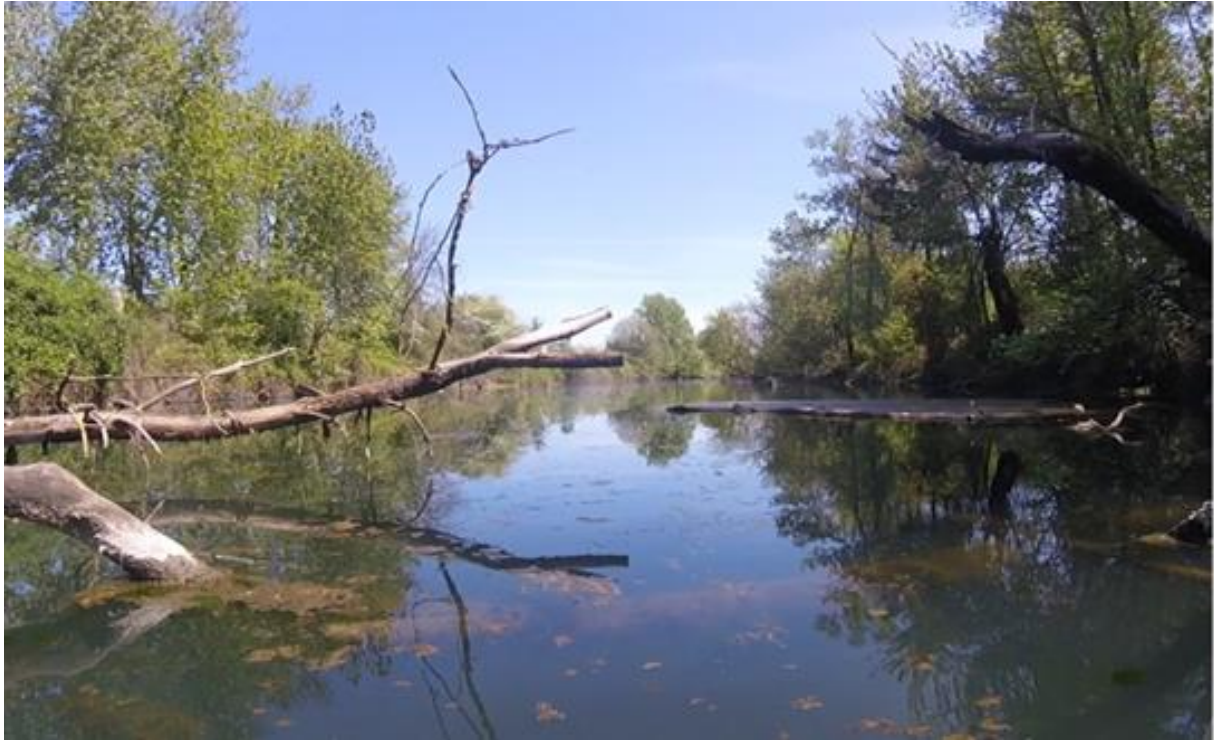
The substrate of Whitaker Slough is largely composed of mud with very dense vegetation growth throughout. The middle portion of the slough provided a noticeable riparian buffer.

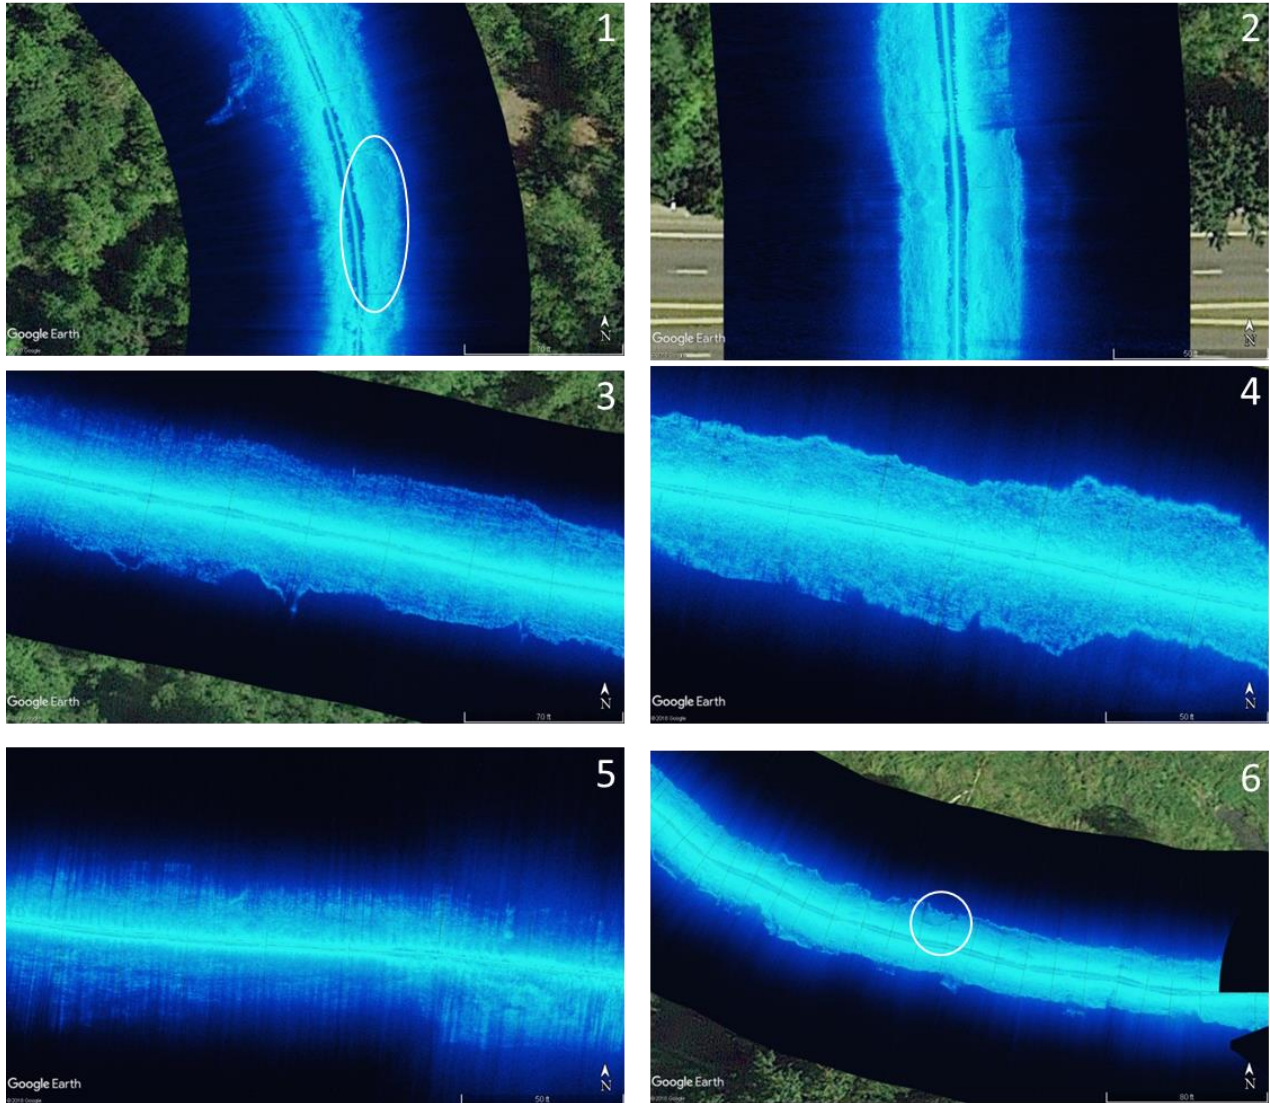
Reach 6: We ended our sonar path 0.35 miles west of Fairview Lake due to shallow depth. The substrate in Reach 6 was largely composed of mud, although dense vegetation prevented us from capturing clear images of the sediment. Image 1 shows a patch of mud visible through the vegetation. Images 2, 3, and 4 show vegetation throughout reach 6. Image 5 illustrates interference in the sonar image from vegetation surrounding the sonar transponder. Some naturally occurring wood was present in Reach 6 (Image 6), although less than in some of the other reaches.

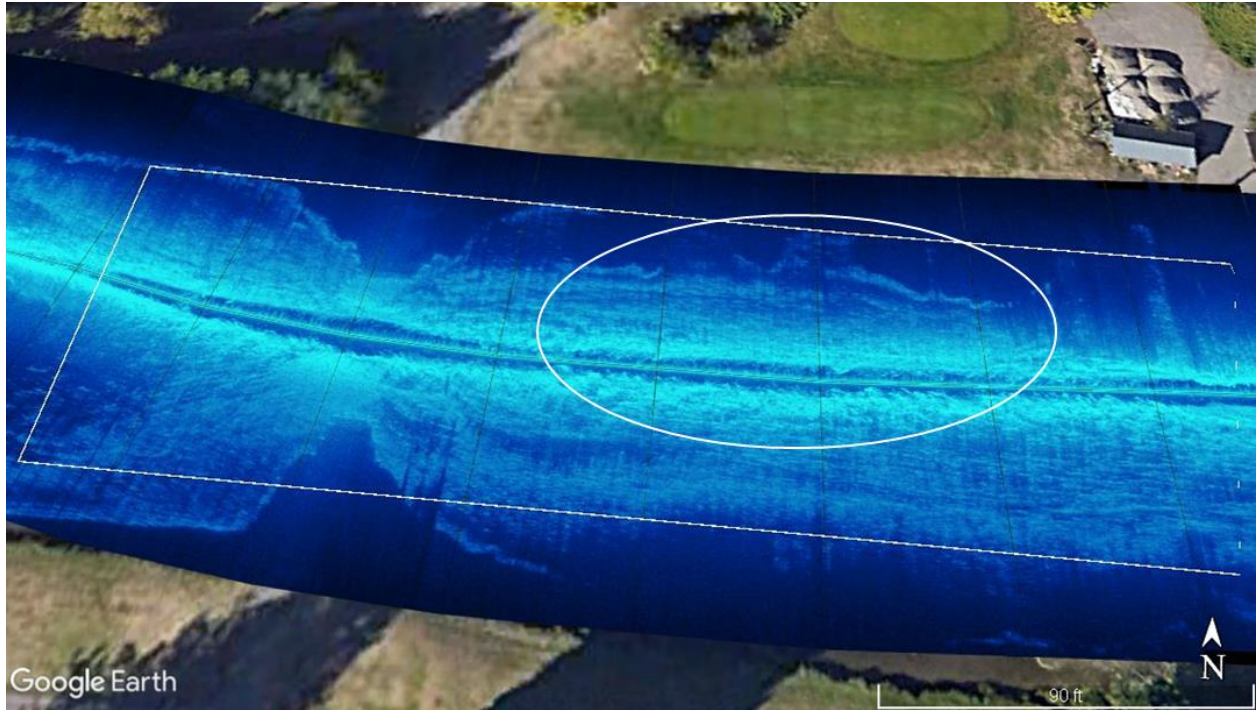
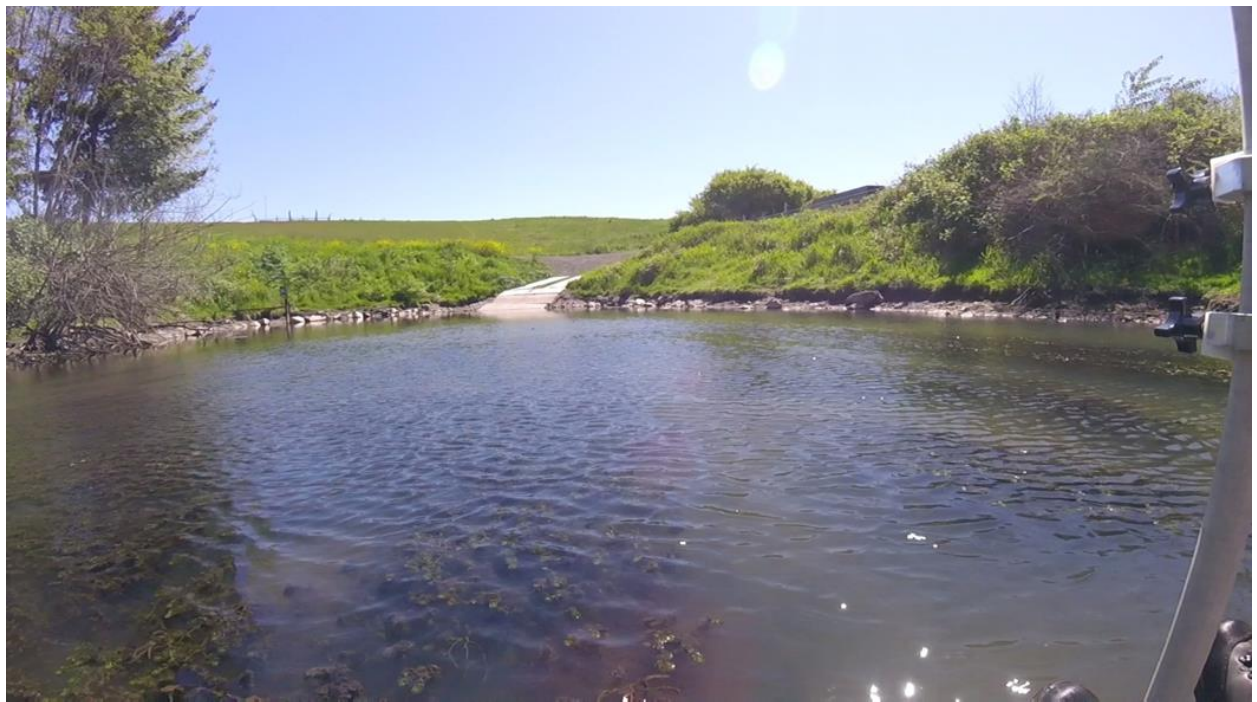
The image above shows a dense concentration of Hydrilla. Notice within the oval highlighted area how the water column is inundated with vegetation. The sonar reflects this vegetation as a brighter, more intense blue, and the image reads as somewhat blurry. The image below is a photo of Hydrilla growth at the 143rd Avenue levee.

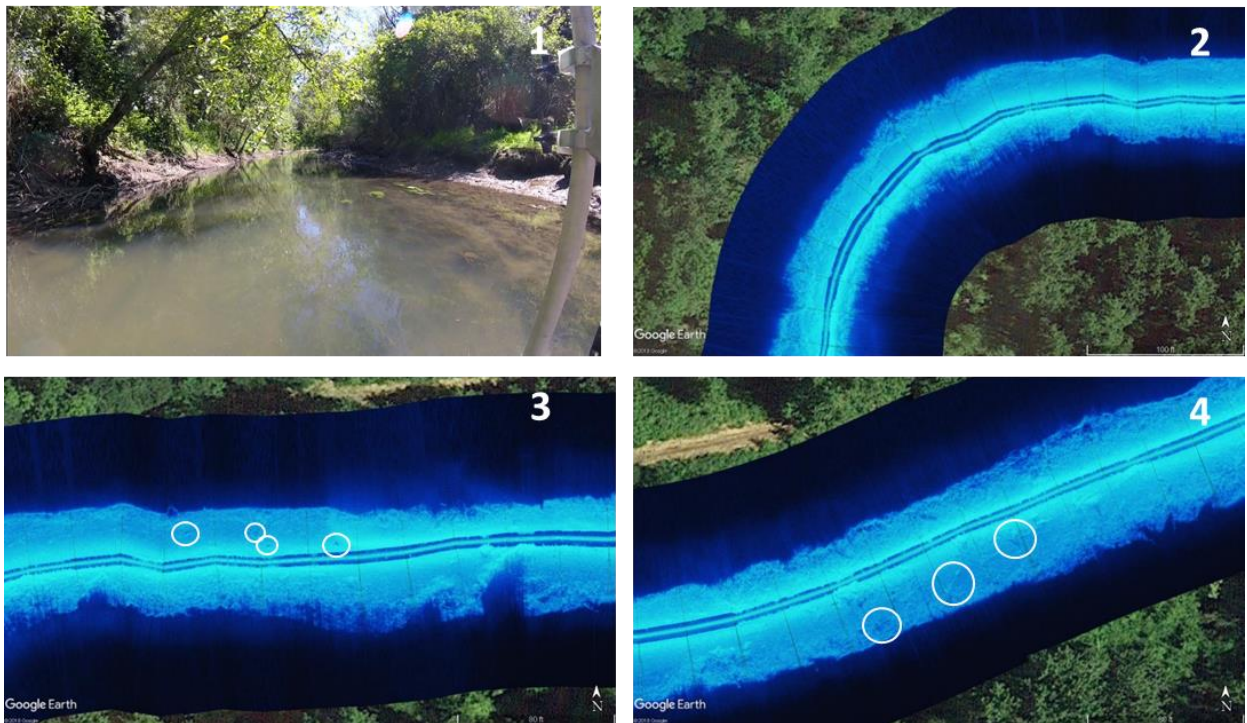
Reach 7: Approximately 0.34 mi in length, the sediment in this section is predominately mud. Shallow depths were observed throughout along with aquatic vegetation. Image 1 is a typical

snapshot from this reach, showing shallow water and vegetation. Image 2 shows the mud substrate, with vegetation toward the edges of the channel. Image 3 shows some assorted small boulders and stumps on the bottom. Image 4 shows small pieces of wood.
