Oregon Department of Fish and Wildlife

Use of a Side Scan Sonar to Describe Habitat Condition in the Columbia Slough

Progress Report No. OPSW-ODFW-2019-5

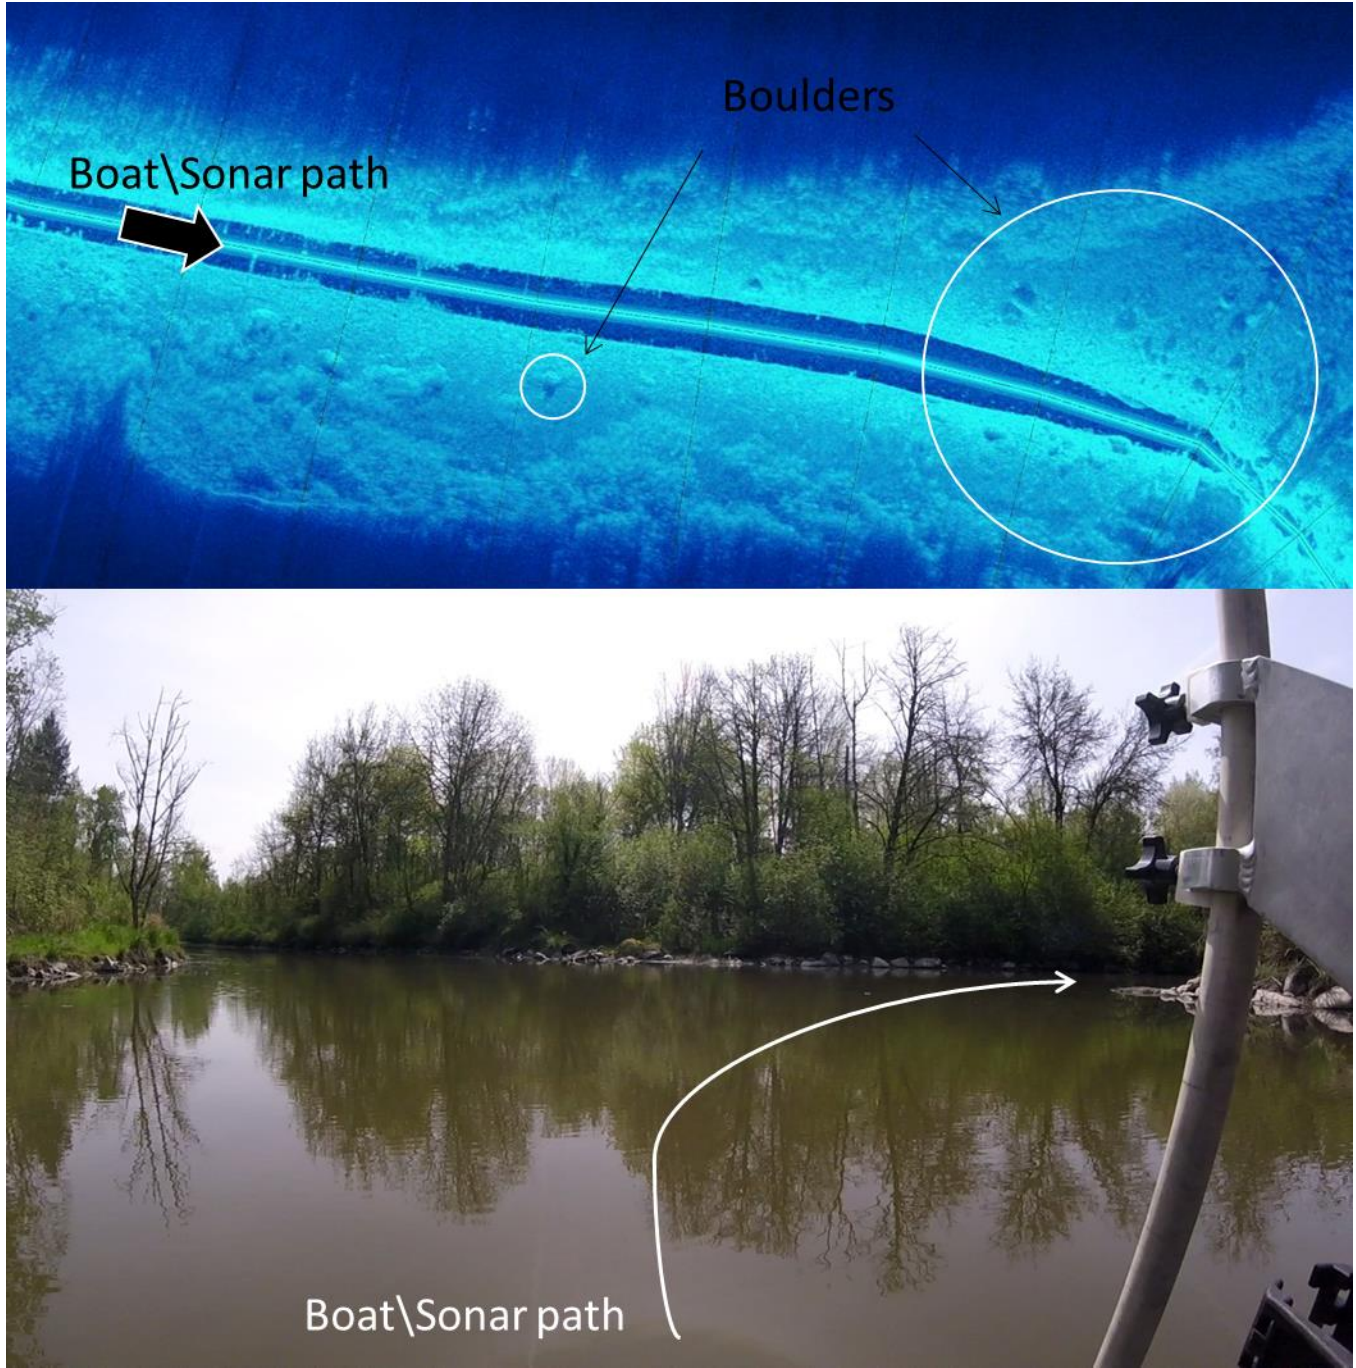
The images above are from the Big Four Corners intersection. The sonar image shows mud substrate with a few boulders scattered throughout. The photograph shows the same location from above the water's surface.
