2022- Monitoring Report for the Clackamas Focused Investment Partnership.

Number OPSW-ODFW-2023-07

PROJECT TITLE: 2022 Monitoring Report for the Clackamas Focused Investment Partnership

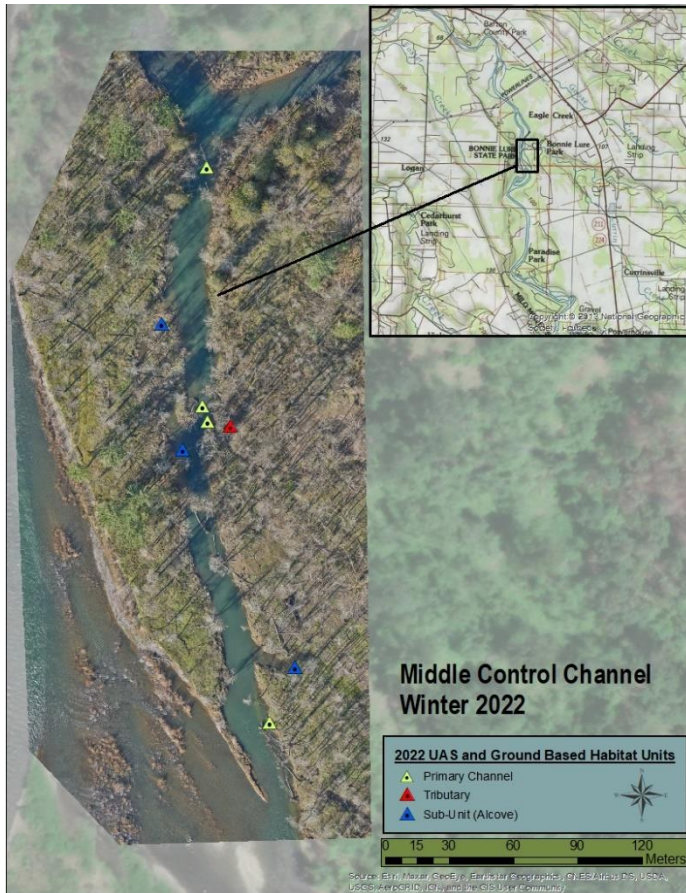
Figure 6. Middle Control Channel. Winter 2022 UAS imagery and ground-based survey points.

The Middle Control Channel is located on the east side of the Clackamas River main channel and flows north 318 meters to form the southwest boundary of the Eagle Creek Complex. Figures 6 and 7 show the Middle Control Channel during the winter and summer of 2022. The Middle Control Channel flows entirely within Bonnie Lure State Recreation Area. Potential movement of the Middle Control Channel is restricted to 220 meters of movement between the main channel of the Clackamas River to the west and the hillslope to the east.

A UAS survey occurred on September 20, 2022, to capture summer flow conditions. The UAS images show minor variations in habitat surface area between the summer and winter (Figures 6 and 7) (Table 9). The Middle Control Channel has good connectivity to the Clackamas mainstem, resulting in minimal habitat loss between the winter and summer seasons. UAS imagery shows that the channel is inundated with water during expected winter flows (Figure 6). Three slack water sub-units provide off-channel refuge from the fast water units of the primary channel, and a tributary enters from the east. UAS imagery shows the watered channel and drying of the three sub-units during summer flows (Figure 7). The UAS imagery also indicates that the tree canopy obscures some of the observable surface area and the tributary. An on-the-ground habitat survey verified the unit boundaries and the tributary location.

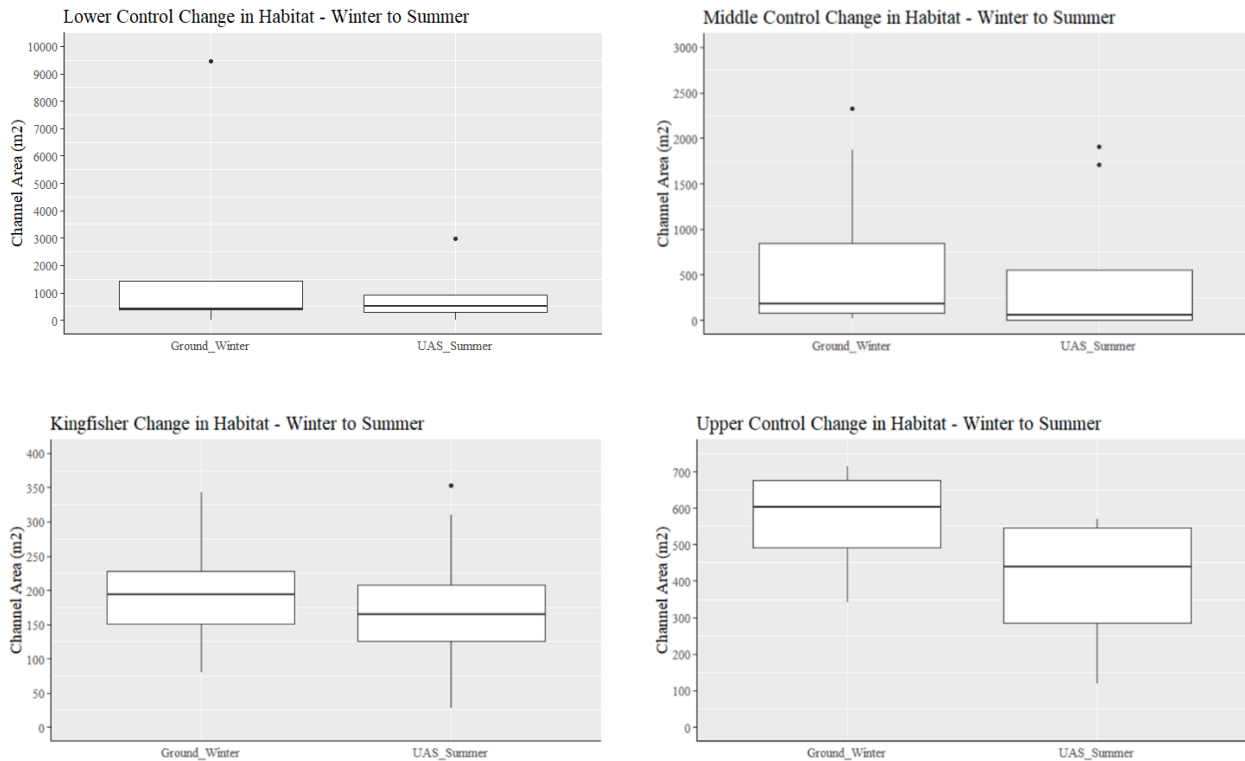
We used paired *t*-tests to describe differences in winter habitat area (m²) using ground surveys and summer habitat area (m²) from UAS survey imagery. Differences were minimal across seasons for most sites (Table 11). Differences observed in the Upper Control and Middle Control (Figure 13) were likely attributed to sub-units drying out in the Middle Control between seasons, and high flows on the Upper Control during the winter ground surveys

The Middle Control and Upper Control had the most change in habitat area between winter and summer. Several alcove subunits in the Middle Control were fully inundated in winter and dry in summer, resulting in a loss of habitat area.

Figure 13. Box plots assessing differences in habitat area (m²) between winter ground surveys and summer UAS survey imagery results.

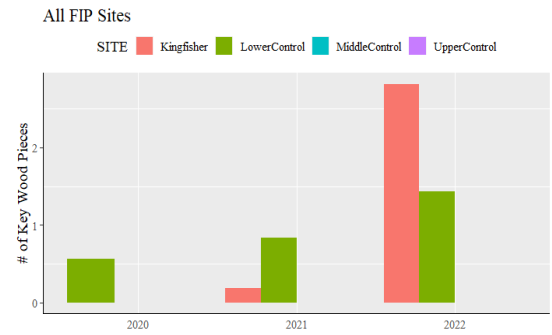
Figure 15. Bar plots describing differences between pre-restoration treatment and post-restoration treatment for wood volume (m³) and the number of key pieces of wood (≥ 12 m in length and 60 cm in diameter) Total/100m primary channel.

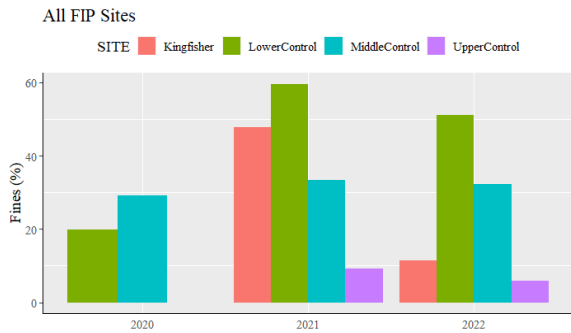
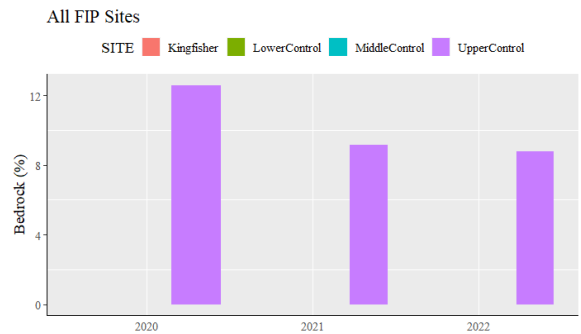
Channel and pool features decreased post-treatment in the Kingfisher Side-Channel, although residual pool depth and riffle depth stayed the same or increased slightly across all sites (Figure 14). Wood volume increased within the Kingfisher restoration site as expected, and a slight increase in wood volume was shown in the Control sites. The number of key pieces of wood (≥ 12 m in length and 60 cm in diameter) increased within the Kingfisher site following restoration, and an increase was seen in the Lower Control Channel (Figure 15). Within stream bedload types, we observed a slight decrease in the percent of fines (silt and sand), an increase in gravel and cobble, and a reduction in the percent of boulders in the Kingfisher Side-Channel following restoration. The Control sites had relatively minor variations in bedload percentages (Figure 16).

Figure 16. Bar plots describing differences between pre-restoration treatment and post-restoration treatment across bedload types.

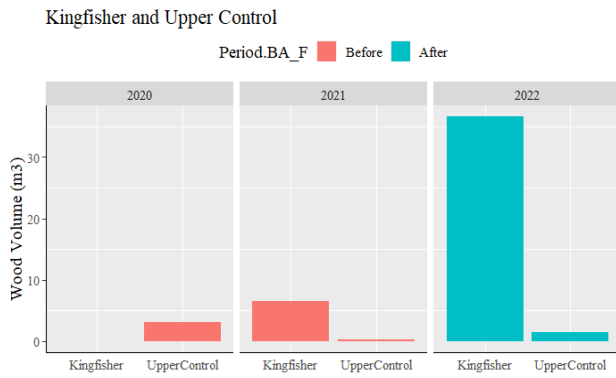
The Upper Control experienced minor differences over three years, whereas the Kingfisher Side-Channel underwent significant changes after restoration efforts were implemented. The Kingfisher Side-Channel showed dramatic changes across fast water habitat metrics and pool habitat (Figure 17). Notably, the incorporation of new wood structures, along with the addition of gravel and cobble substrates, resulted in a considerable increase in these metrics (Figures 18, 19).

Figure 18. Bar plots describing differences between pre-restoration and post-restoration wood volume and the number of key wood pieces (total/ 100m primary channel) of the Kingfisher Side-Channel and the Upper Control.

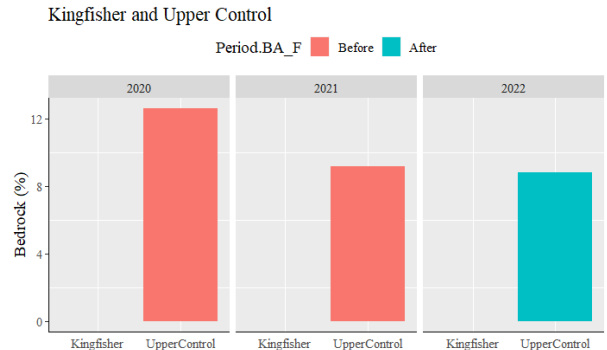
Figure 19. Bar plots describing differences between pre-restoration and post-restoration bedload percentages of the Kingfisher Side-Channel and the Upper Control.
