2021- Monitoring Report for the Clackamas Focused Investment Partnership.

Number OPSW-ODFW-2022-07

PROJECT TITLE: 2021 Monitoring Report for the Clackamas Focused Investment Partnership

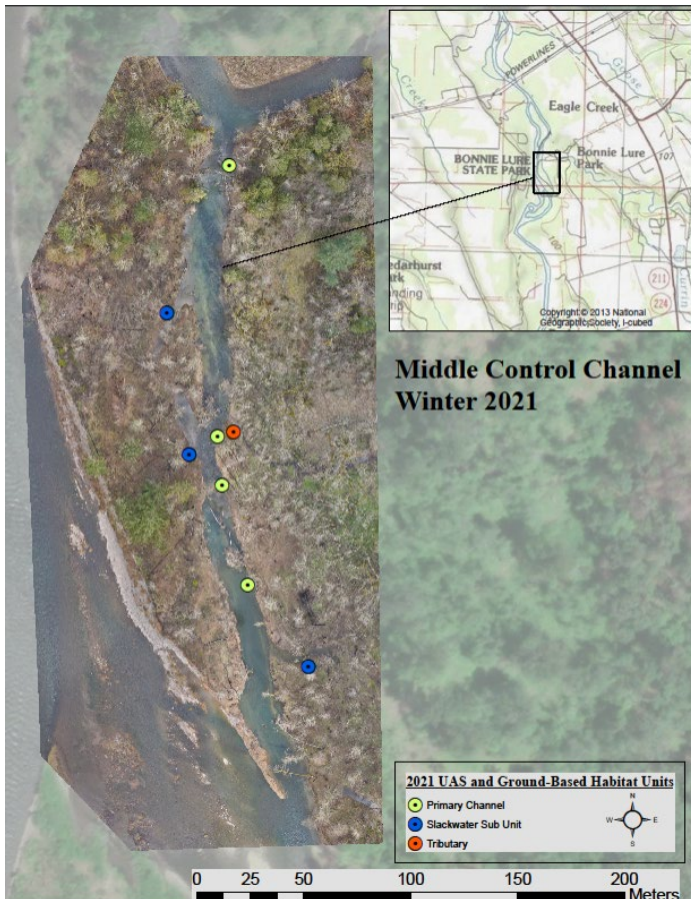
The Middle Control Channel is located on the east side of the Clackamas River main channel and flows north 318 meters to form the southwest boundary of the Eagle Creek Complex. Figures 8 and 9 show the Middle Control Channel during the winter and summer of 2021. The Middle Control Channel flows entirely within Bonnie Lure State Recreation Area. Potential movement of the Middle Control Channel is restricted to 220 meters of movement between the main channel of the Clackamas River to the west and the hillslope to the east.

Figure 8. Middle Control Channel. Winter 2021 UAS imagery and ground-based survey points.

A UAS survey occurred on September 21, 2021, to capture summer flow conditions. The UAS images show minor variations in habitat surface area between the summer and winter seasons (Figures 8 and 9) (Table 9). The Middle Control Channel has good connectivity to the Clackamas mainstem and, as a result, has minimal habitat loss between the winter and summer seasons. UAS imagery shows that the channel is inundated with water during expected winter flows (Figure 8). Three slack water sub-units provide off-channel refuge from the fast water units of the primary channel, and a tributary enters from the east. UAS imagery shows the watered channel and drying of the three sub-units during summer flows (Figure 9). The UAS imagery also shows the presence of the tree canopy obscures some of the observable surface area and the tributary. An on-the-ground habitat survey was conducted and verified the unit boundaries and the tributary location.

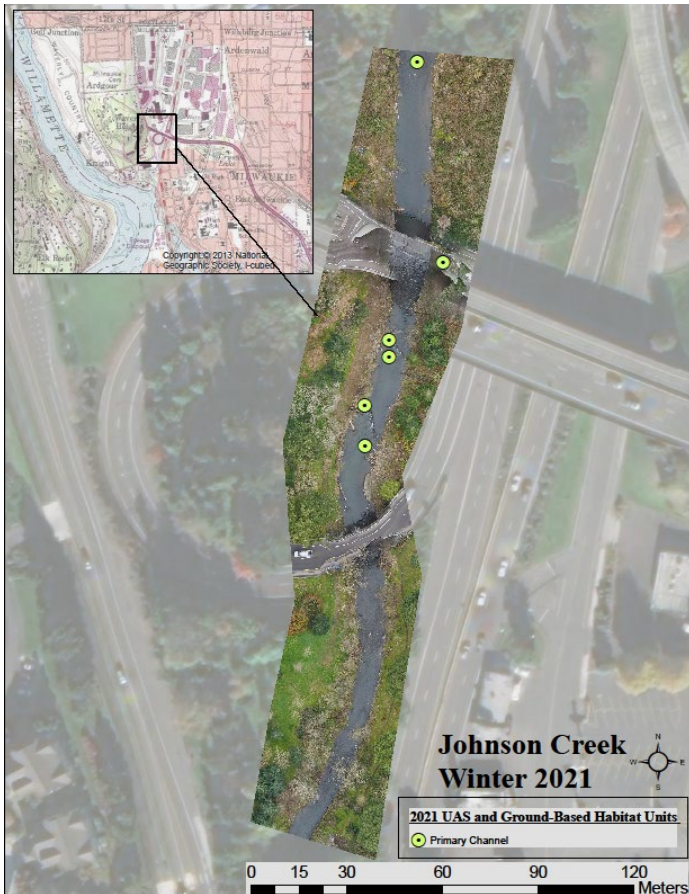
The Lower Johnson Creek Habitat Enhancement site is located within the city of Milwaukee. Johnson Creek flows south for 228 meters within the site boundaries and is bound to the east by Highway 99. Figures 14 and 15 show Johnson creek during the winter and summer of 2021. The site is crossed by Highway 224 near the beginning of the survey. High terraces on each bank constrain the Johnson Creek channel. A valley width index (VWI) suggests the active channel could potentially move more than 20 times between hillslope toes. Current land use and existing structure will likely keep Johnson Creek in its present channel location.

Figure 14. Johnson Creek. Winter 2021 UAS imagery and ground-based survey points.

The UAS images show minor variations in habitat surface area between the summer and winter seasons (Figures 14 and 15) (Table 9). The UAS imagery shows that the channel is completely inundated with water during typical winter (Figure 14) and summer flows (Figure 15). The emergence of the summer foliage does obscure some of the UAS capabilities to image the unit boundaries. The ground-filtered DEM layer aided in establishing channel boundaries when canopy cover obscured areas on the orthomosaic. An on-the-ground habitat survey was conducted and did provide details on the unit boundaries and depths and provided a secondary verification.

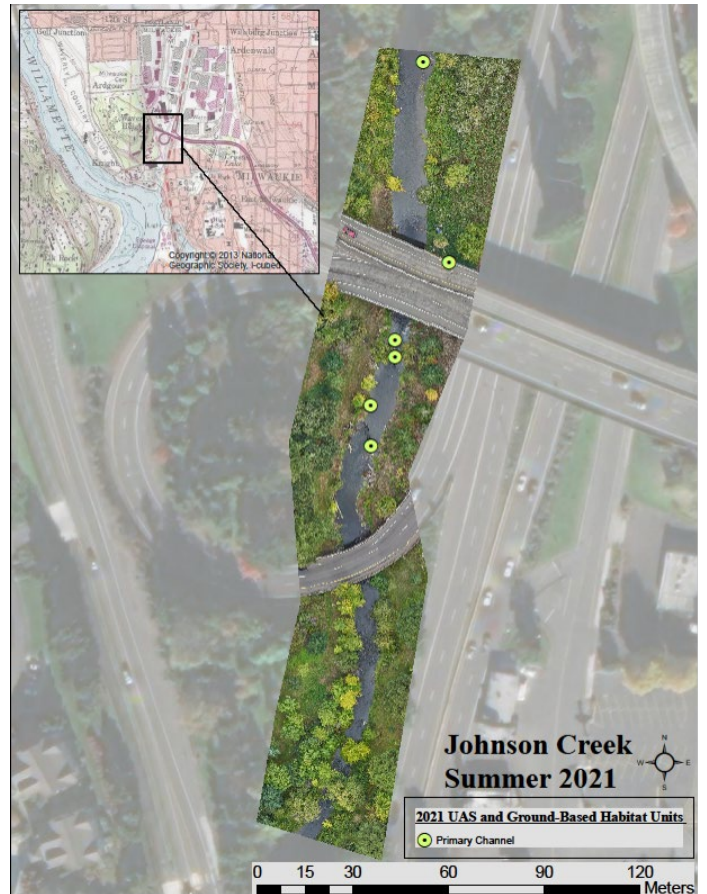
Figure 15. Johnson Creek. Summer 2021 UAS imagery and ground-based survey points.

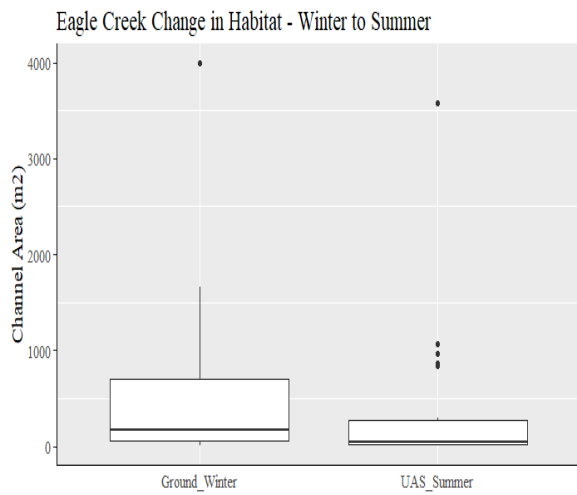
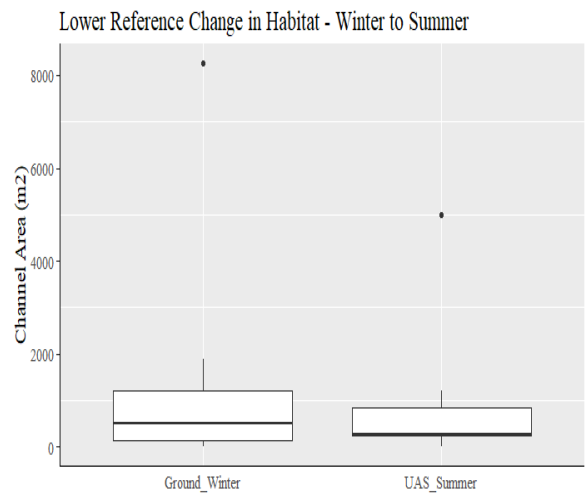
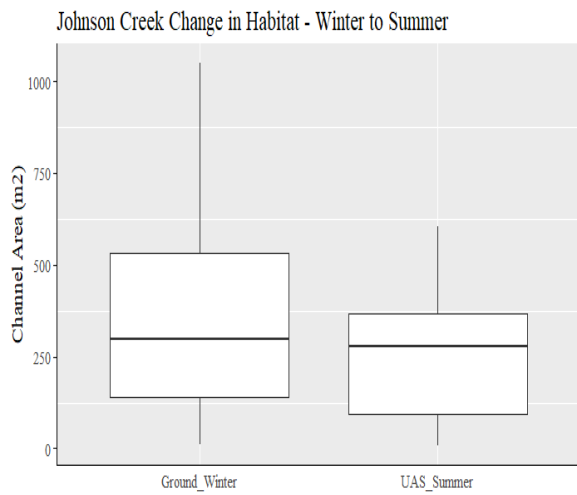
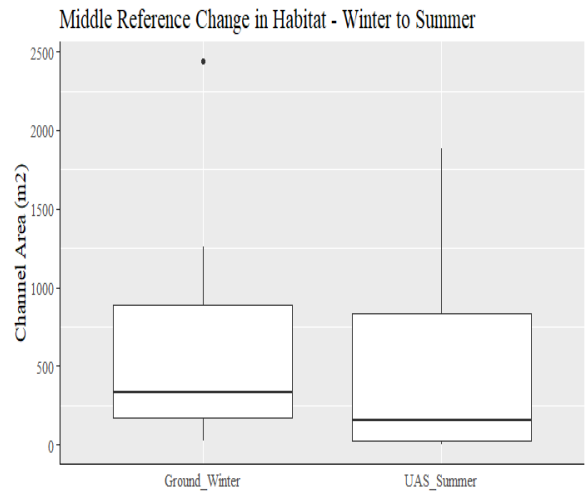
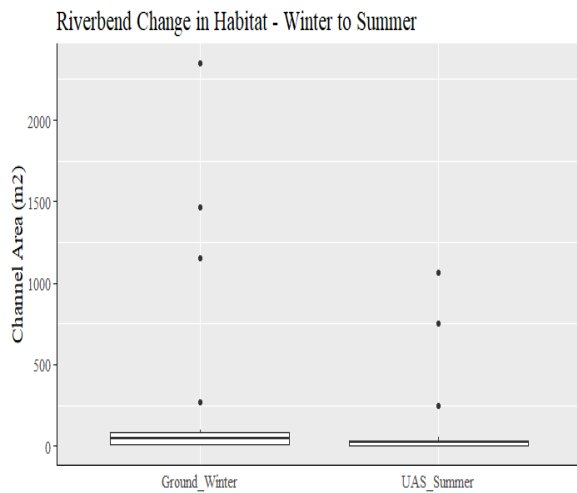
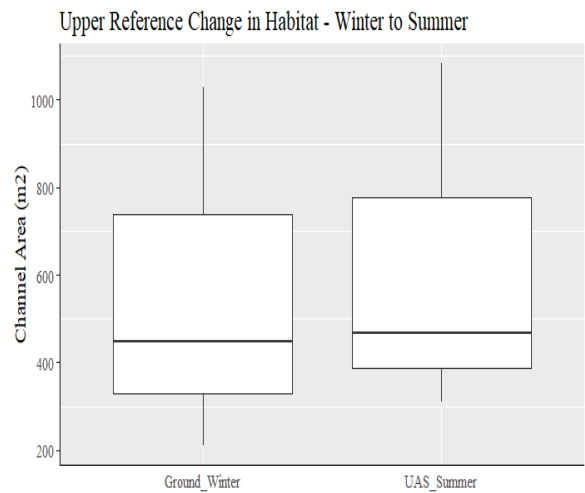
Figure 20. Box plots assessing differences in habitat area (m<sup>2</sup>) between winter ground surveys and summer UAS survey imagery results.

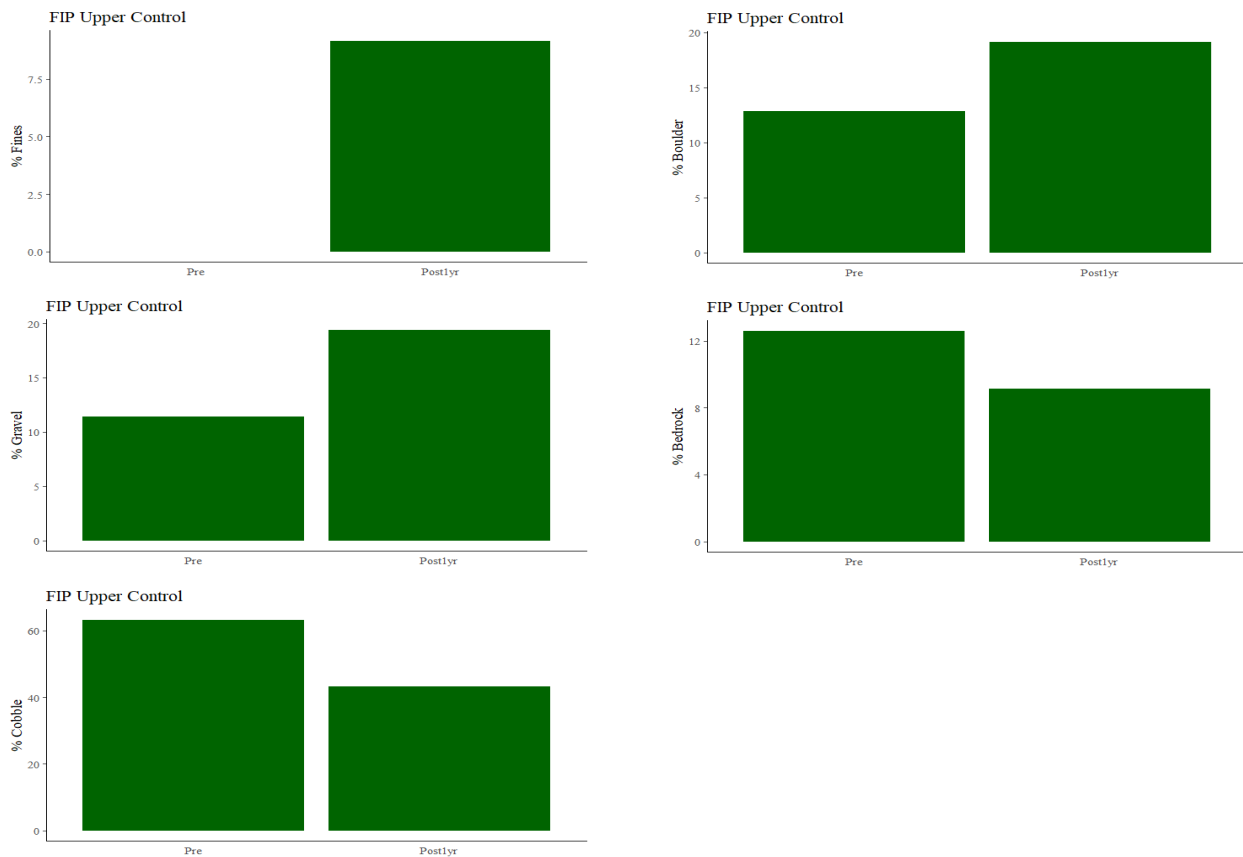
Differences were observed across bedload types within the Upper Control Channel (Figure 26). The percentage of fines (sand and silt), gravel, and boulder increased while the percentage of bedrock decreased. The percent of cobble decreased consistently with other FIP sites monitored during the sampling period.

Figure 26. Bar plots for the Upper Control Channel describing differences between year one and year two of monitoring effort across bedload types.
