Use of a Side Scan Sonar to Describe Habitat Condition in the Columbia Slough

Progress Report No. OPSW-ODFW-2019-5

Guide to Viewing and Interpreting Sonar Images in the Columbia Slough, Oregon

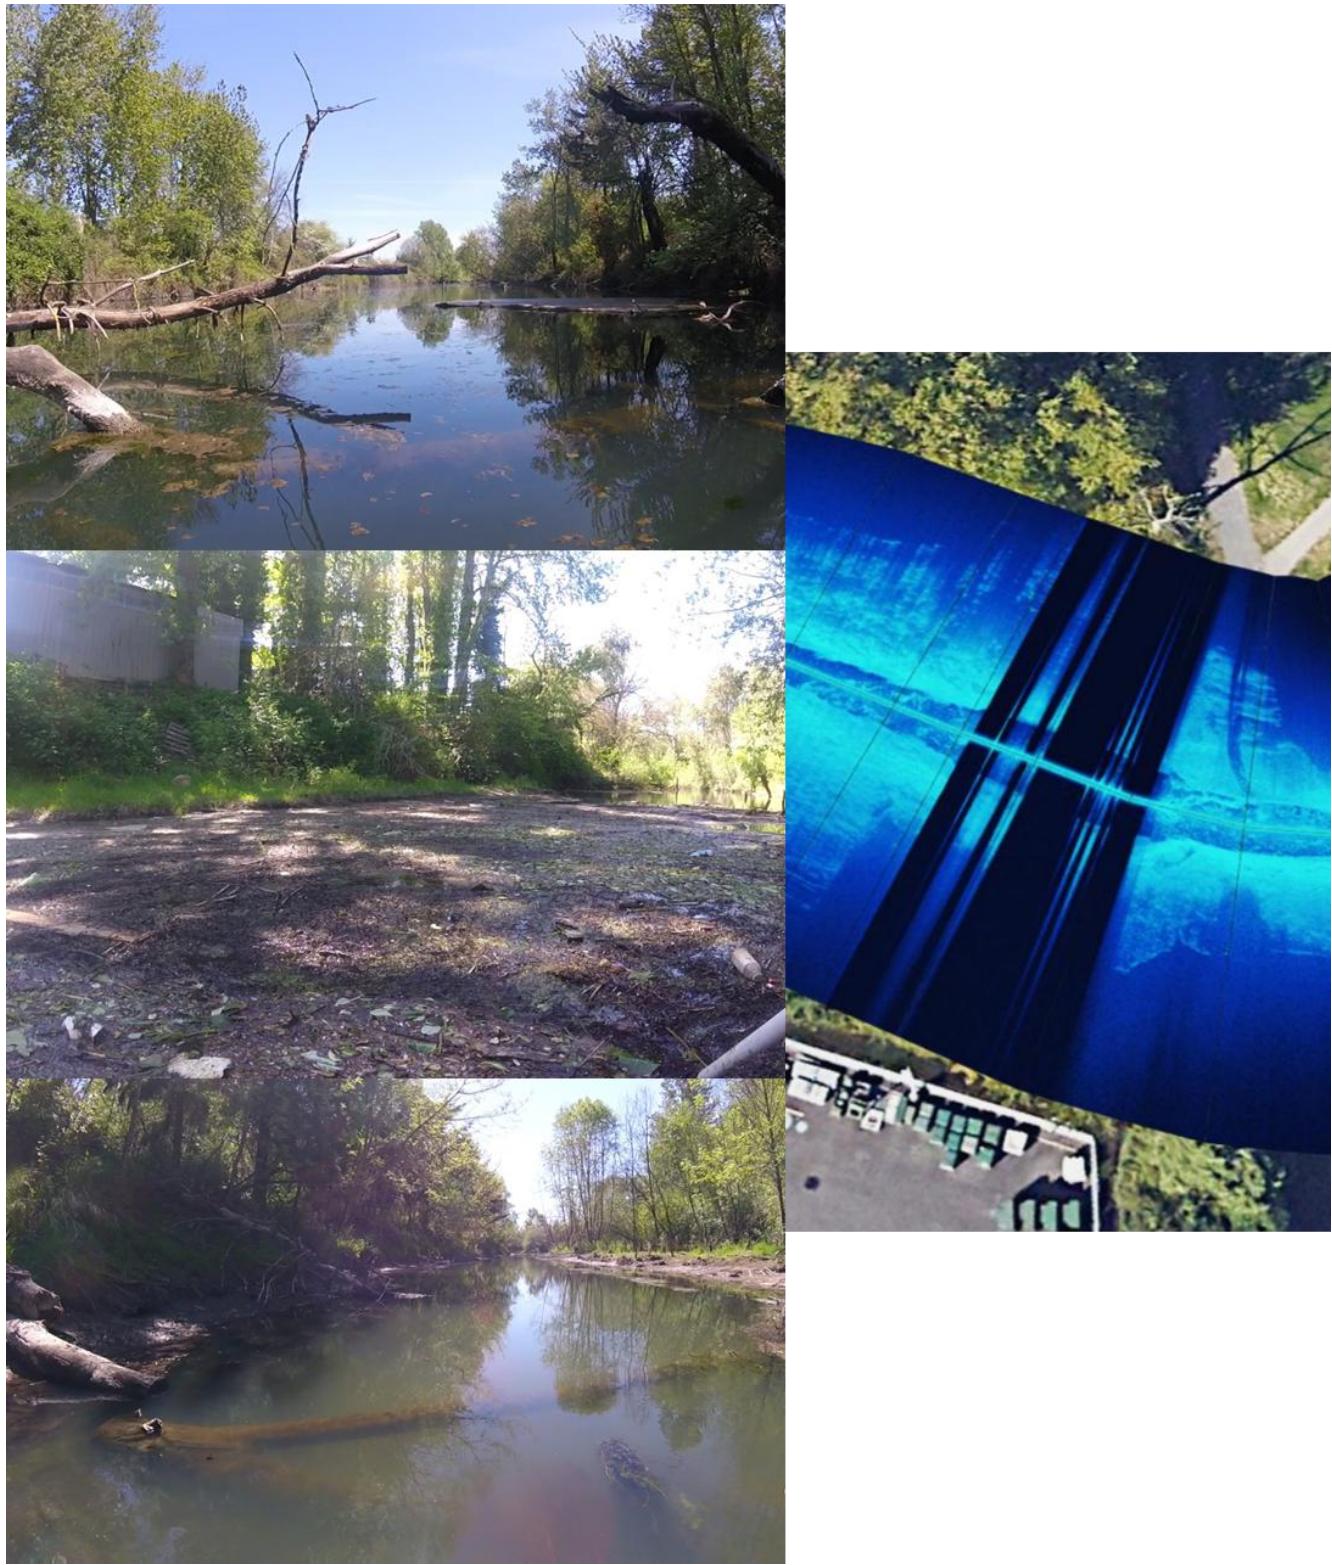
Numerous obstacles including large logs, branches, mats of vegetation, and trash impeded the sonar requiring the transponder to be lifted out of the water. The image on the right shows a lack of sonar data where the transponder was lifted out of the water.

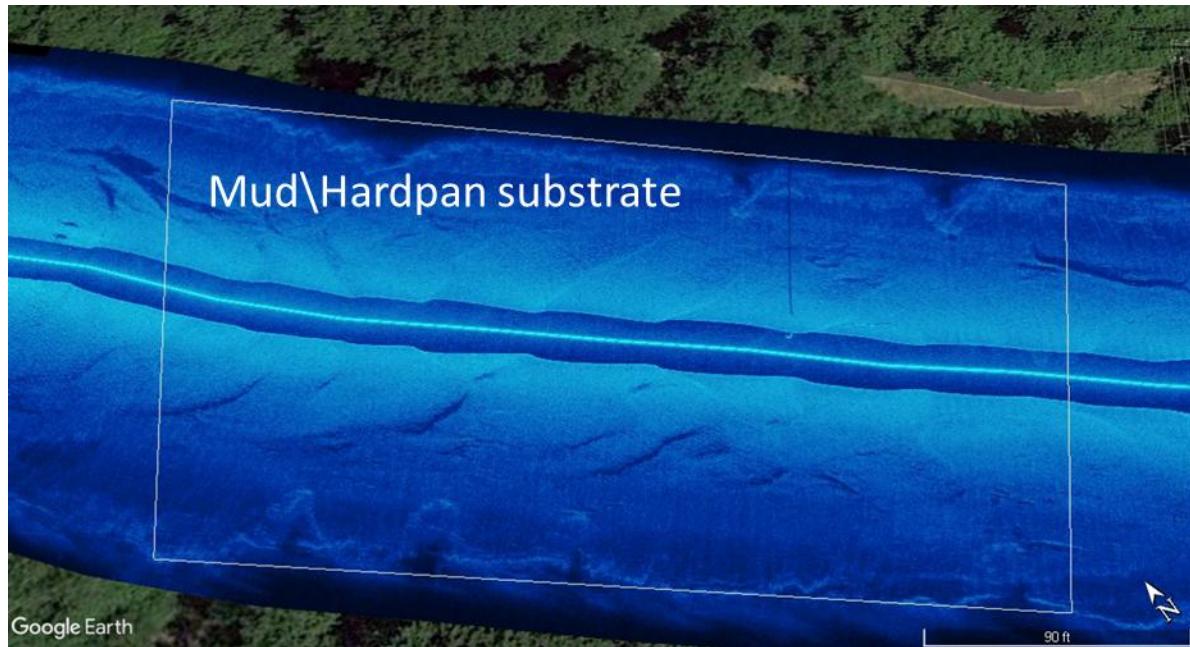
The substrate of the Columbia Slough consists primarily of mud\hardpan throughout the entire length. Concentrations of vegetation are dense and more prolific in the shallow upper reaches of the slough.

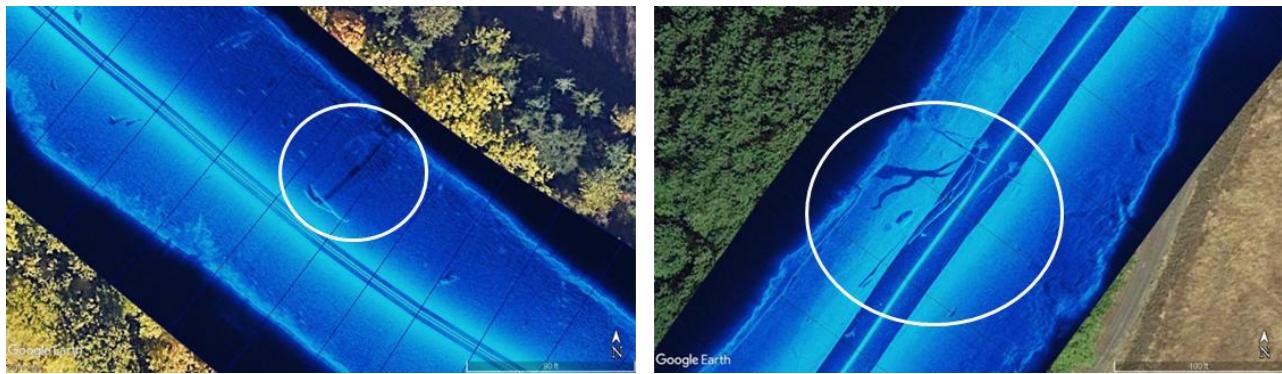
Tree branches, Reach 1: The shadow behind the image on the left shows that the branch extends up into the water column on the left hand side of the sonar transducer, while the image on the right shows the branches extending up into the water column directly under the transducer.

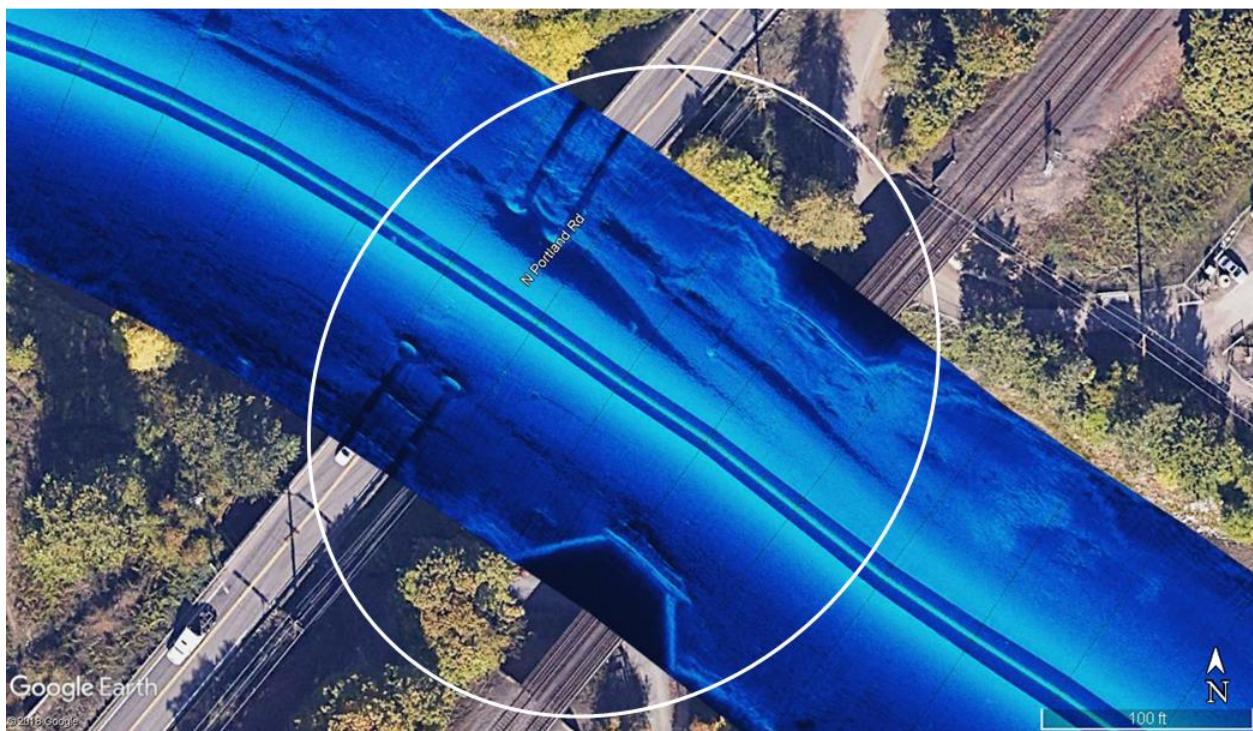
Reach 1 bridge structure; the various types of supporting foundations for bridges can be seen in Reach 1. These include North Lombard Street near North Kelley Point Park Road (top), and a bridge on North Portland Road and its neighboring railroad bridge (bottom).

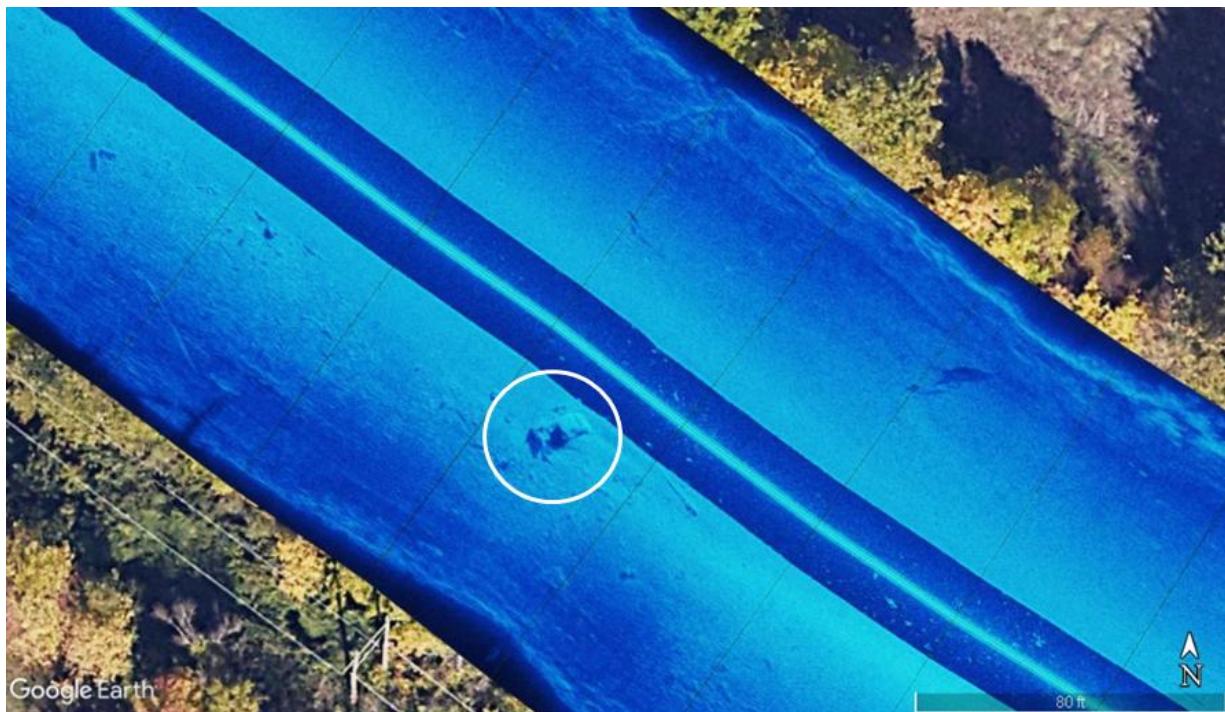
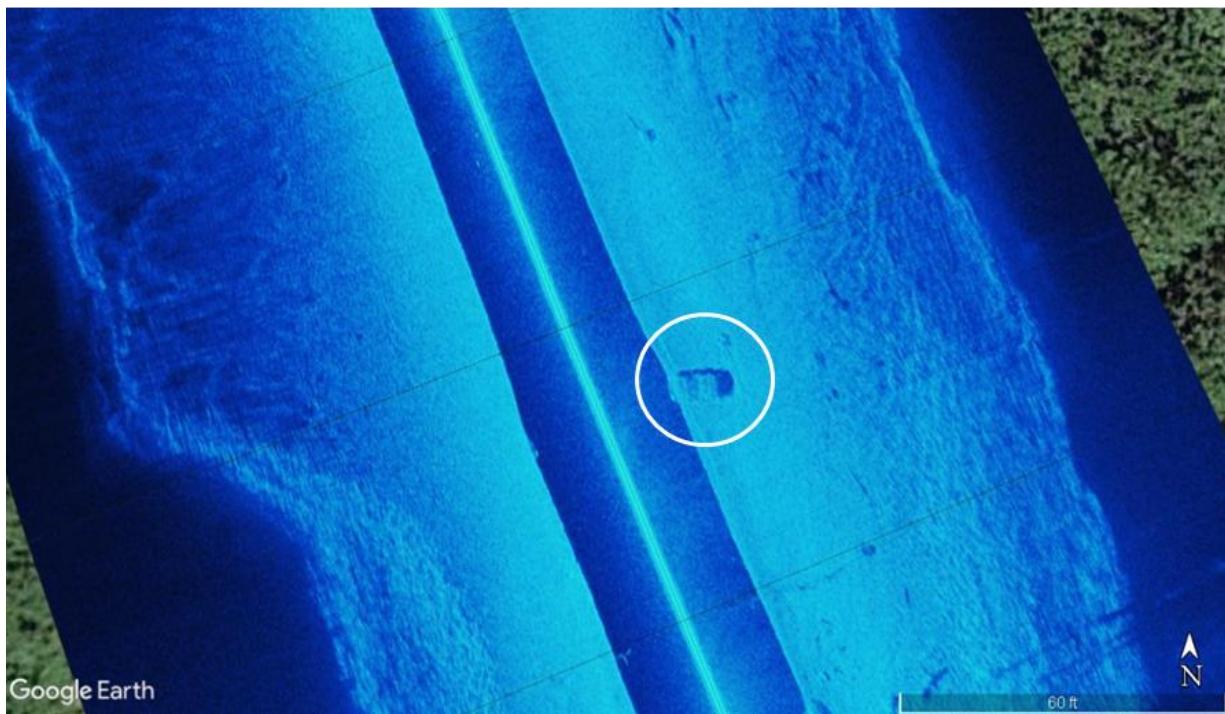
Reach 1 also contained some man-made objects that were unanticipated, such as these two objects that appear to be cars.

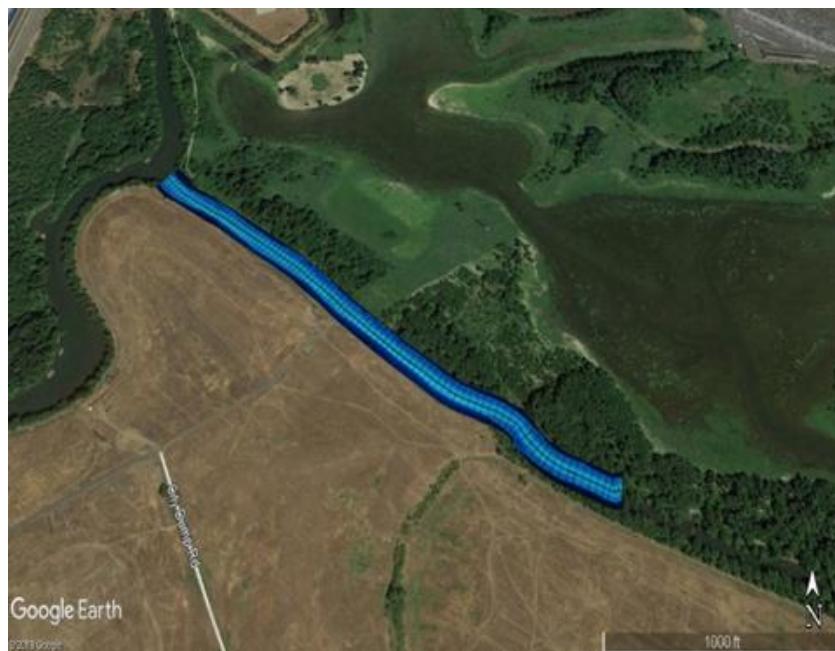
The substrate in Reach 2 consisted of mud \hardpan throughout the entirety of the side channel. Also of note are many pieces of large wood. Several schools of fish were observed with the sonar as well.

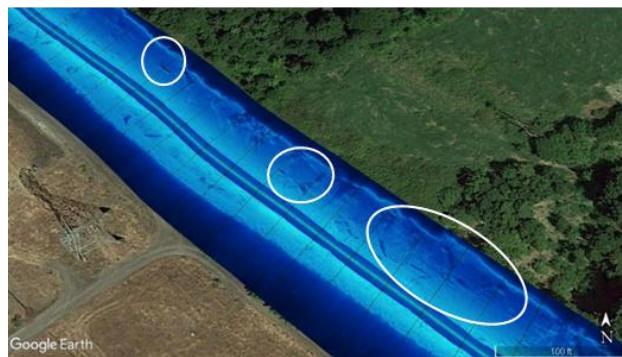
Highlighted above are a number of large wood pieces seen throughout the side channel.

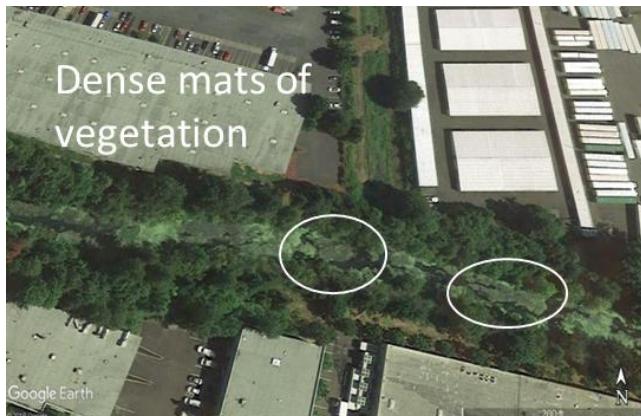
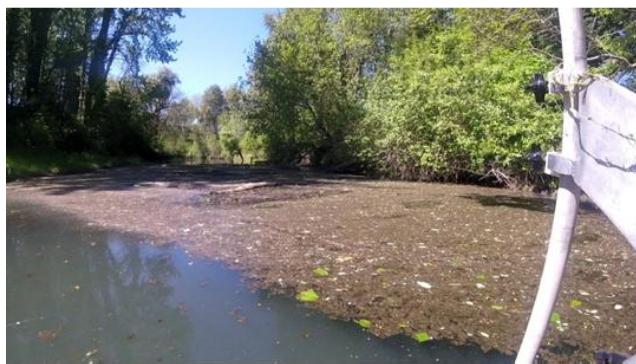
This section of the slough is narrow and shallow, and heavily inundated with vegetation. The substrate is mud/hardpan throughout. At several locations within this reach the vegetation is so thick that it is nearly impassable. The images above highlight some of the dense vegetation in Reach 4.

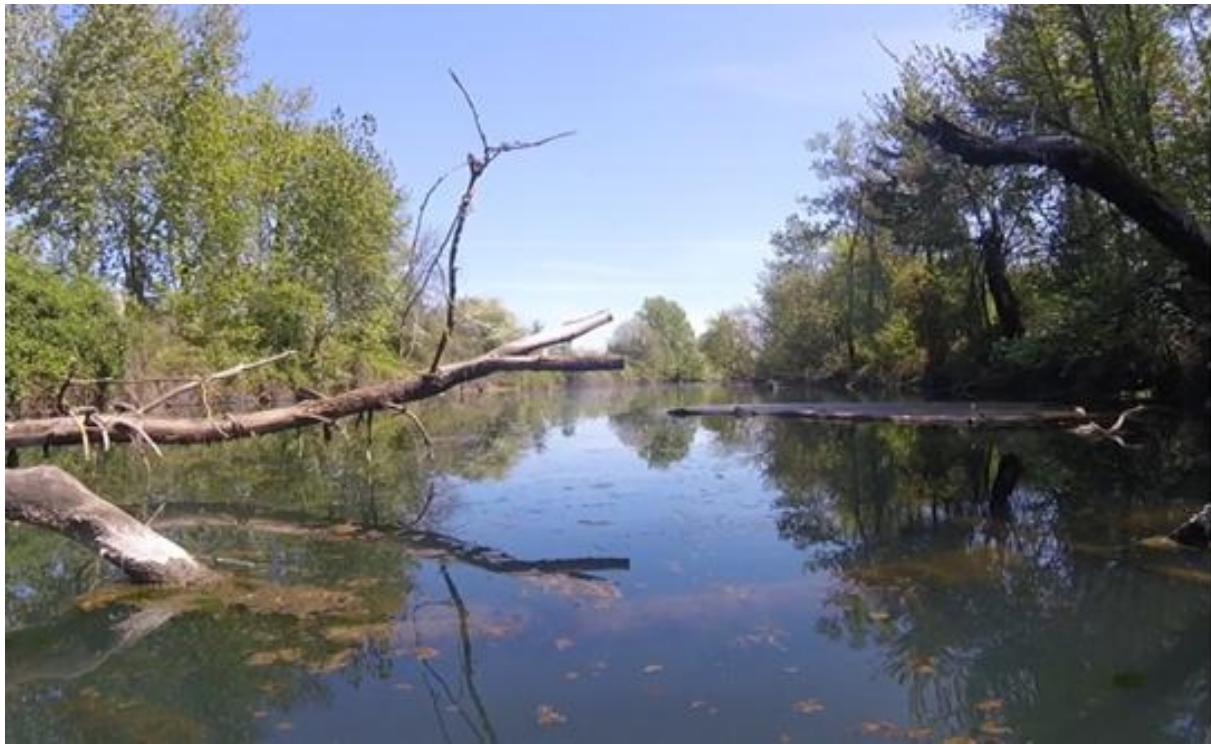
The substrate of Whitaker Slough is largely composed of mud with very dense vegetation growth throughout. The middle portion of the slough provided a noticeable riparian buffer.

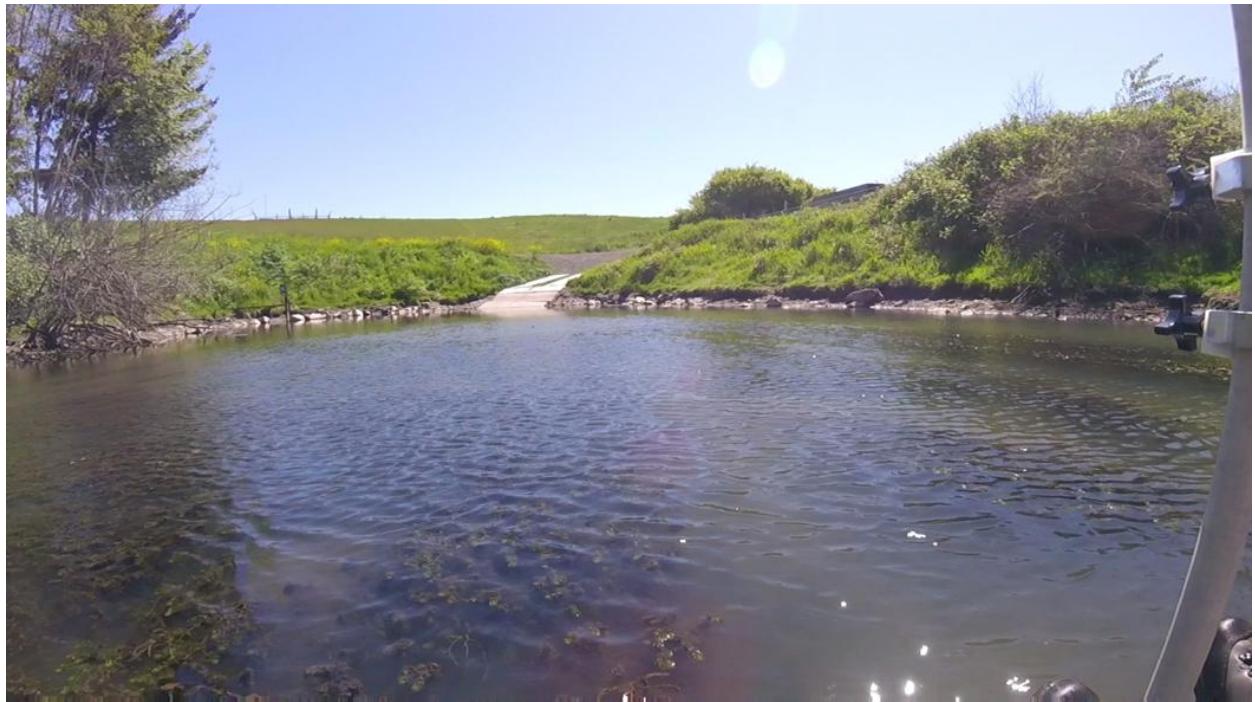
The image above shows a dense concentration of Hydrilla. Notice within the oval highlighted area how the water column is inundated with vegetation. The sonar reflects this vegetation as a brighter, more intense blue, and the image reads as somewhat blurry. The image below is a photo of Hydrilla growth at the 143rd Avenue levee.
